Xbox 360 Top Vent Replacement

Top vent replacement.

Use this guide to remove the gray plastic top vent from your Xbox 360.

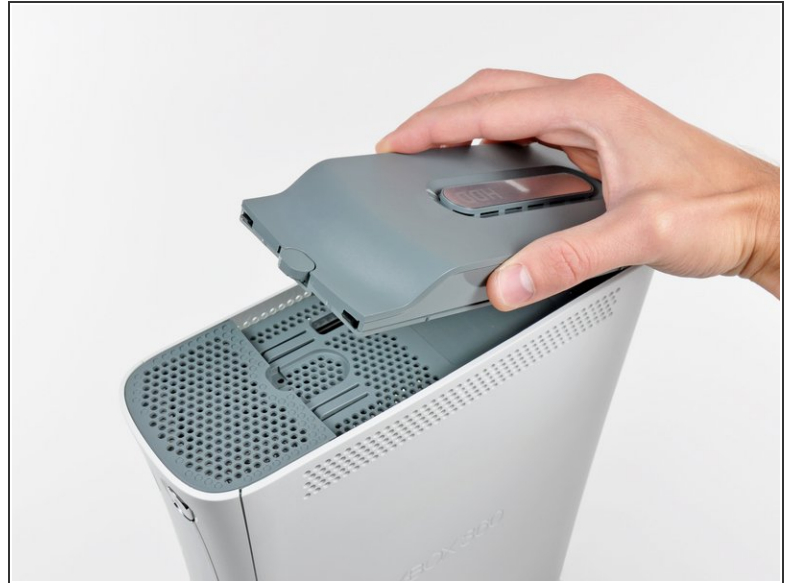
Step 1 — Hard Drive

- Grasp the hard drive assembly and press the release button while lifting its front edge.
- Remove the hard drive assembly from the top vent.

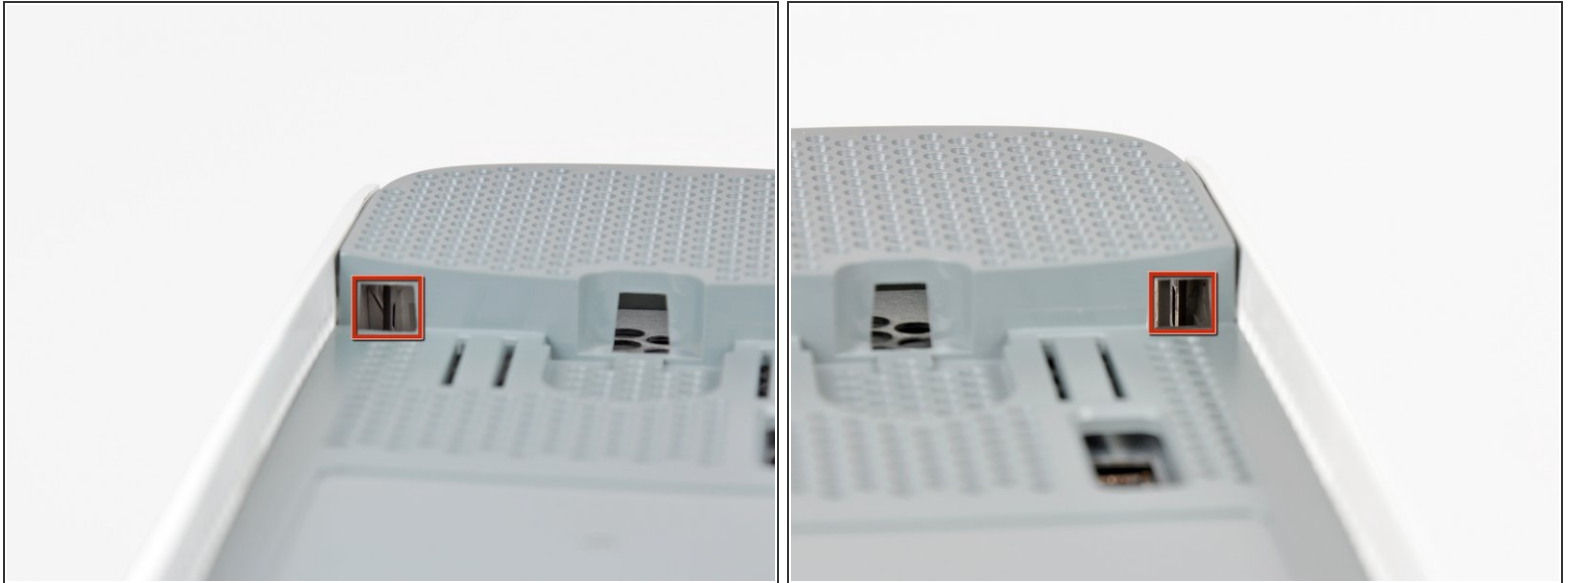
Step 2 — Top Vent

- ☞ Stand the console vertically with the top edge facing up.
- The top vent is secured to the console via clips. The first two clips are located underneath the top vent closest to the faceplate, as shown in the pictures.

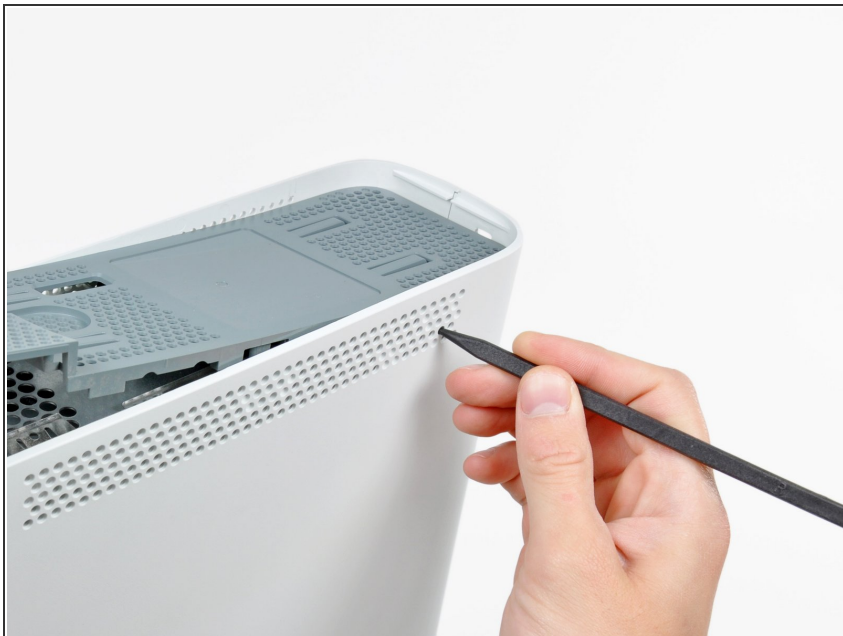
Step 6

- Use the tip of your spudger to release the clip on the top vent nearest the back of the Xbox's upper case.
