# Xbox 360 Top Vent Replacement

Top vent replacement.

Use this guide to remove the gray plastic top vent from your Xbox 360.

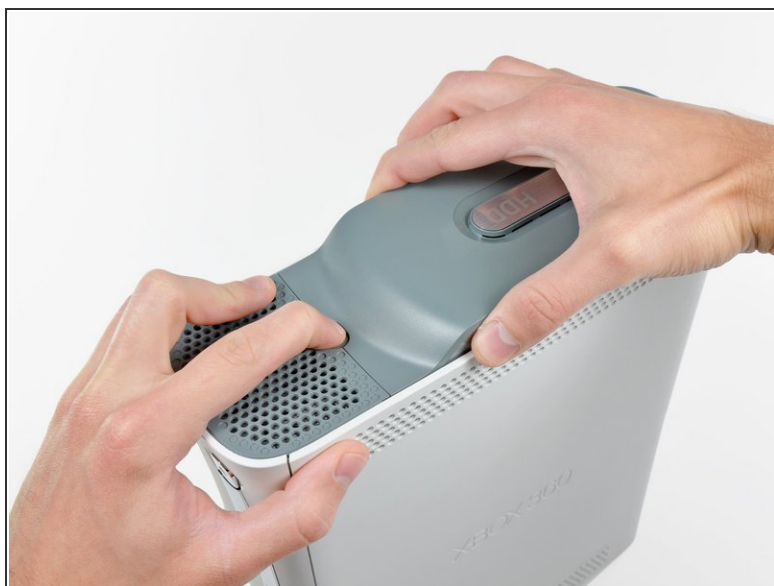
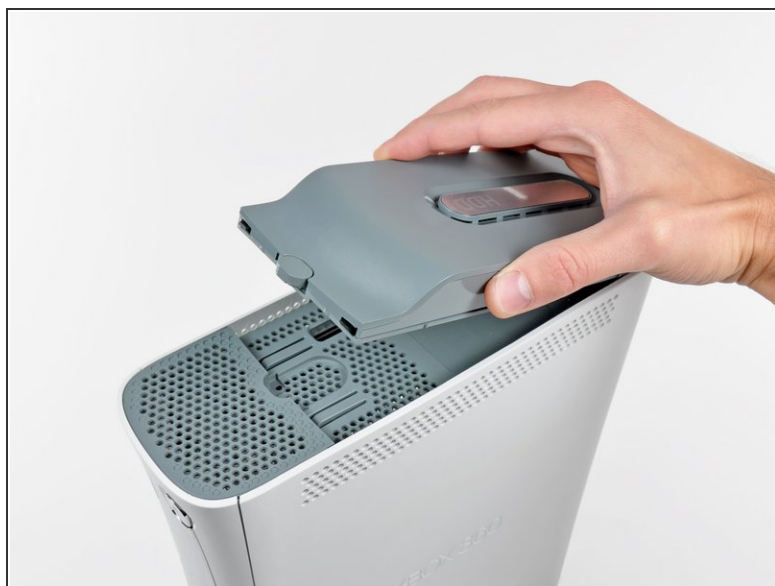
## Step 1 — Hard Drive

- Grasp the hard drive assembly and press the release button while lifting its front edge.
- Remove the hard drive assembly from the top vent.

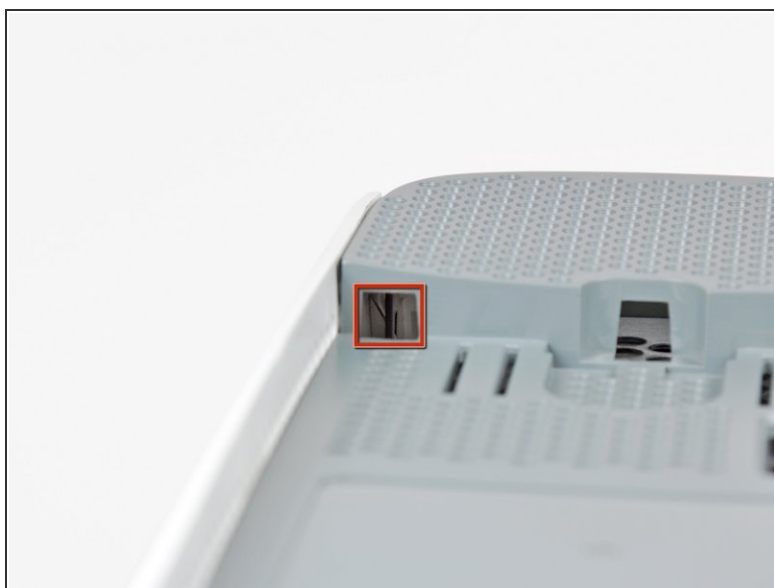
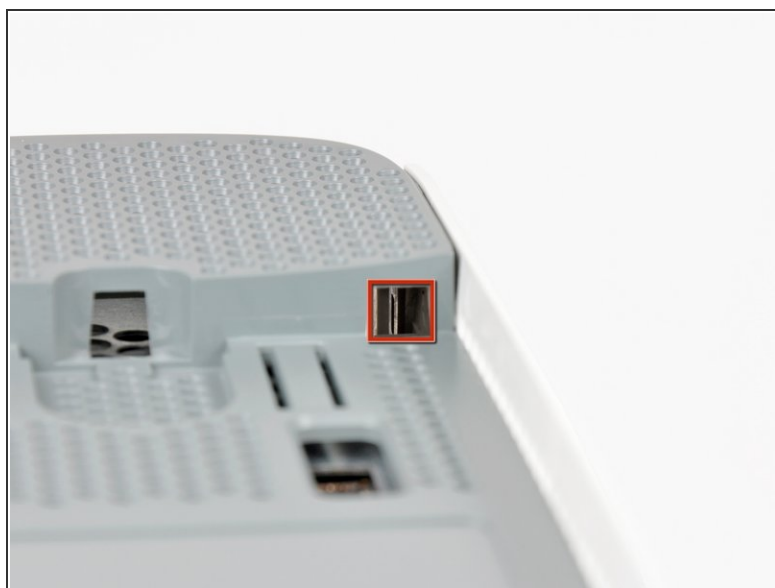
## Step 2 — Top Vent

- ☑ Stand the console vertically with the top edge facing up.
- The top vent is secured to the console via clips. The first two clips are located underneath the top vent closest to the faceplate, as shown in the pictures.

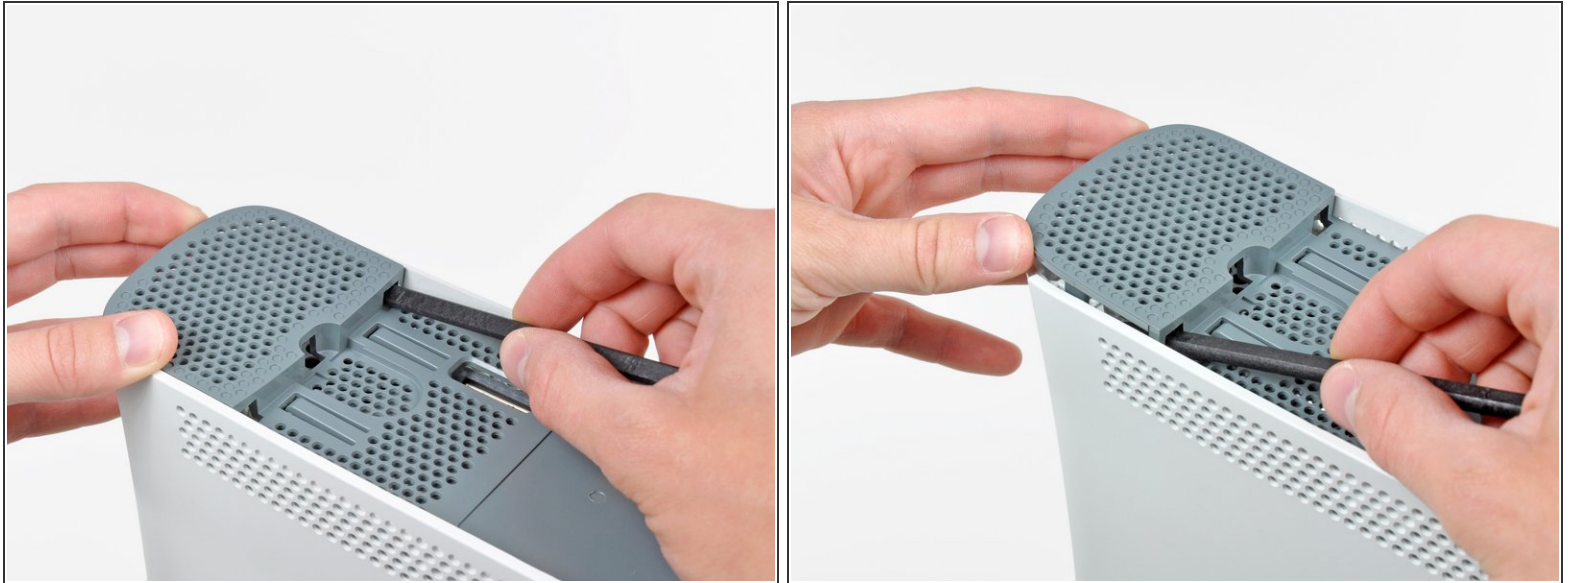
### Step 3

- Insert the flat end of a spudger into the small gaps previously mentioned to release the clips.
- ⓘ You may also use the long finger of an Xbox 360 opening tool to accomplish this task.

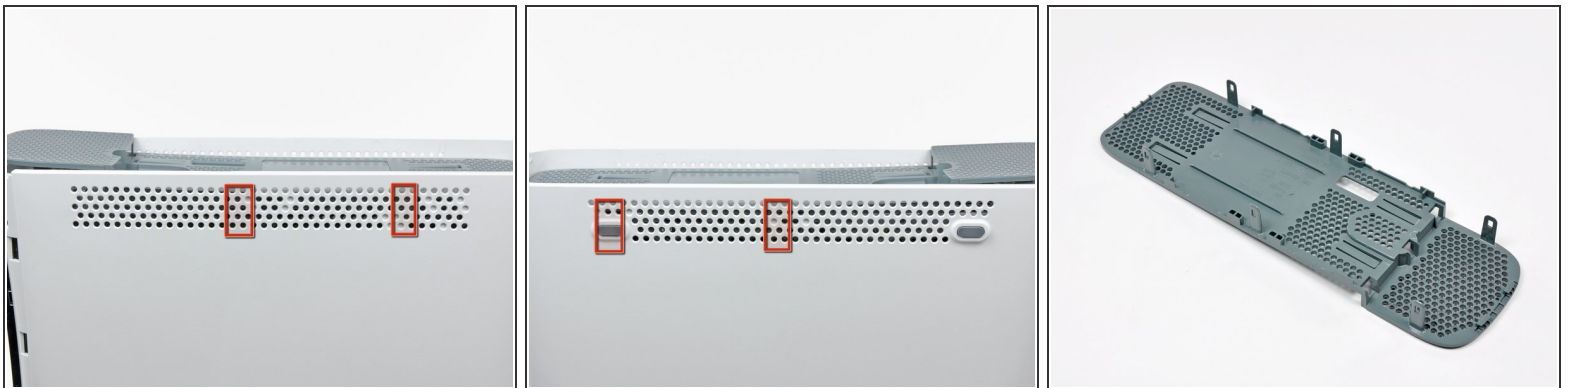
### Step 4

- ⓘ In the next few steps, you will use the tip of a spudger or the finger of an Xbox 360 opening tool to release the clips along the left and right sides of the top vent. Their locations are highlighted in red.

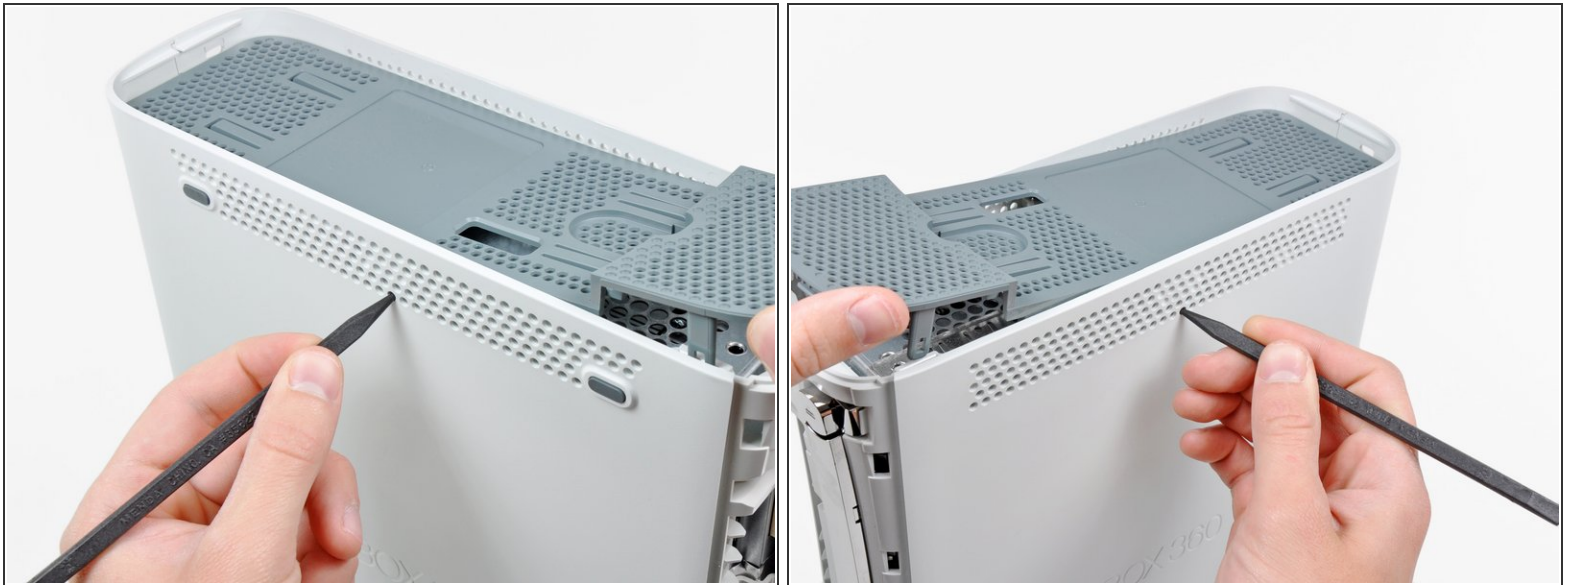
## Step 5

- To release the clips, work from the middle of the top vent.
- While slightly lifting the front edge of the top vent, use the tip of a spudger to push the clips closest to the center of the top vent towards the inside of the console.
