Smart Tweezers and LCR-Reader LCR-meter Flex Cable Replacement

This guide shows how to replace the flex cable for Smart Tweezers ST-5S and LCR-Reader

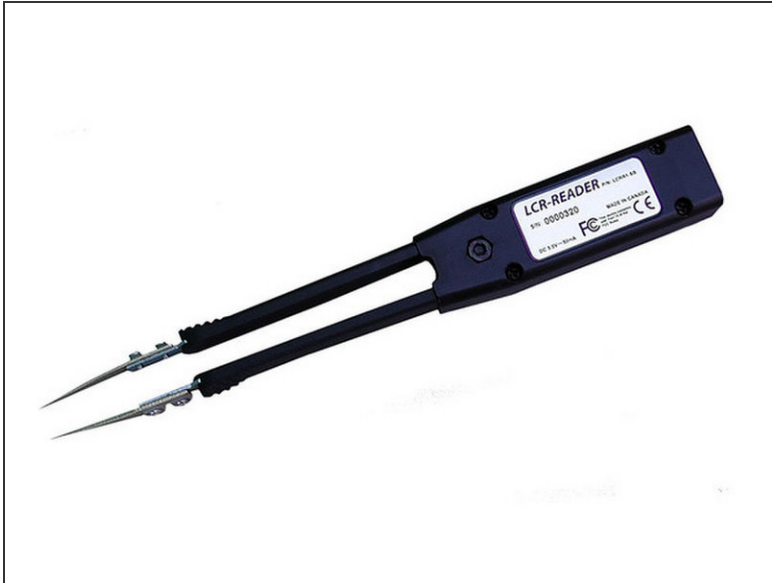
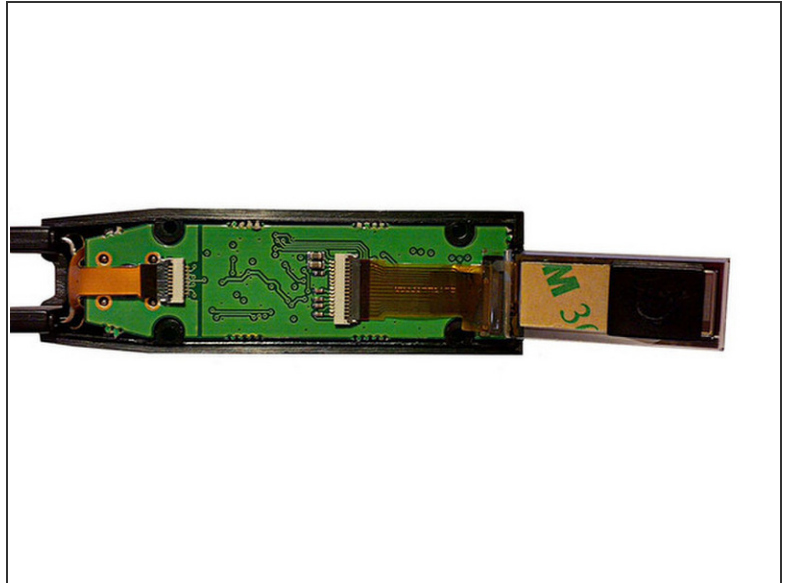
Step 1 — Opening the device

- Begin by removing the 4 screws in the back of the device using a #00 Philips screwdriver

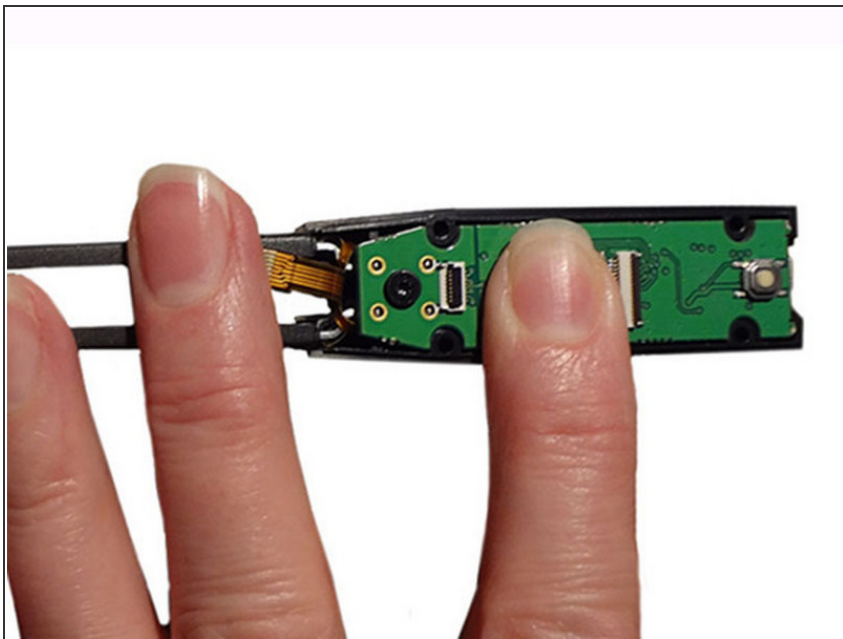
Step 2 — Removing the PCB

- Gently open the zif connector that leads to the tips. Remove the tab, allowing access to the centre screw.
- Using a T6 torx screwdriver, remove the centre screw. A nut on the back of the device will fall loose. The PCB can now be removed.

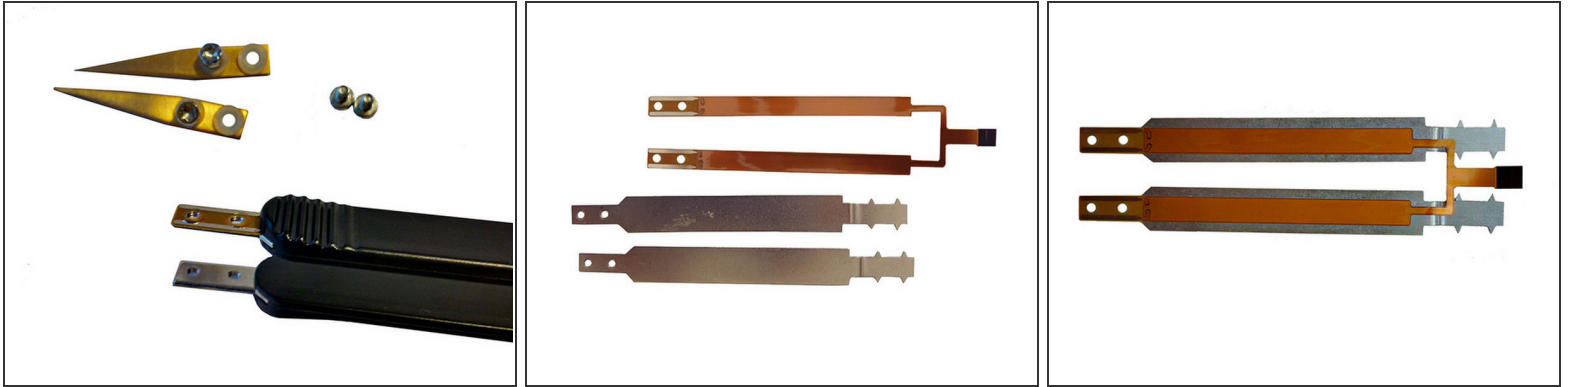
Step 3 — Removing the tips and replacing the flex

- Remove the tips from the arms.
- Remove the arms from the slots in the bottom of the housing
- Peel the old flex off of the arms.
- Clean off any old glue from the arms using isopropyl

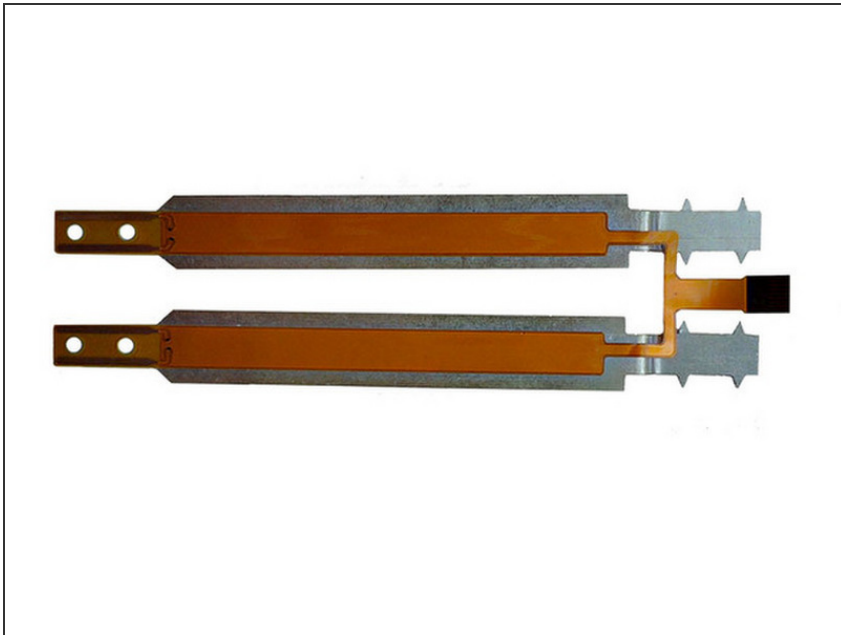
Step 4 — Replacing the flex

- Carefully put the new flex cable on the arms. Be sure to line up the holes as perfectly as possible. Any overlap may cause false readings.

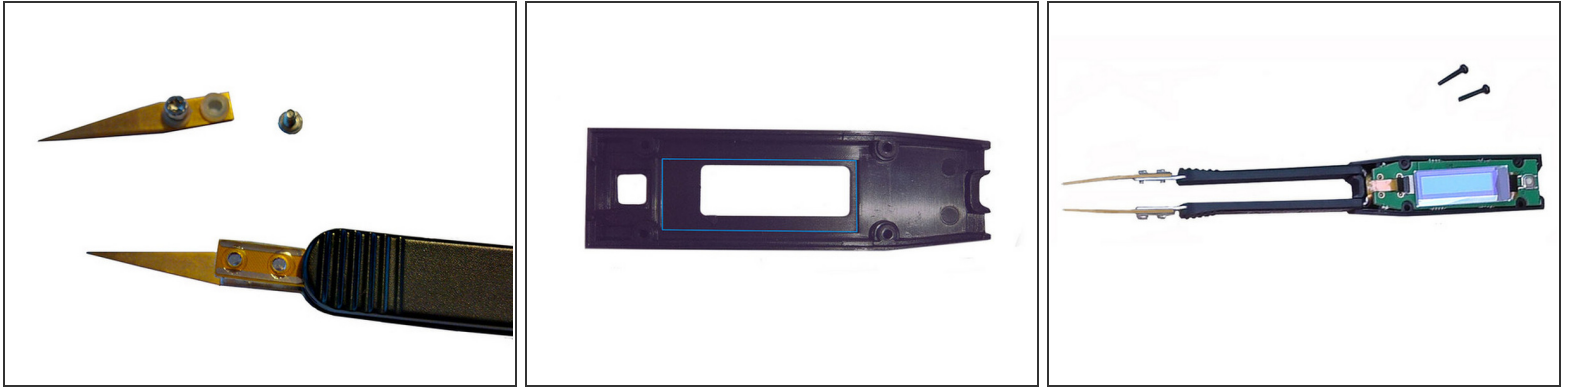
Step 5 — Putting the device back together

- Reinsert the arms into the slots in the housing, and replace the PCB.
- Tighten in the PCB with the centre screw.
- Reconnect the tab from the arms into the zif connector. Touch the arms to test if they are measuring.
- Replace the top housing. Be sure to carefully fit the screen into the rectangle in the top housing; failing to do so may damage the screen.
- Replace the 4 screws in the bottom.
- Replace the tips after cleaning with isopropyl.
- If the device begins to give false readings, remove the tips and clean again. If the problem persists, look for bits of debris. Tiny pieces of metal caught in the screw threads or between the tips and the flex can cause the misreadings.
