Ryobi P202 Bit Storage Clip Replacement

How to replace the Bit Storage Clip on the Ryobi P202 power drill.

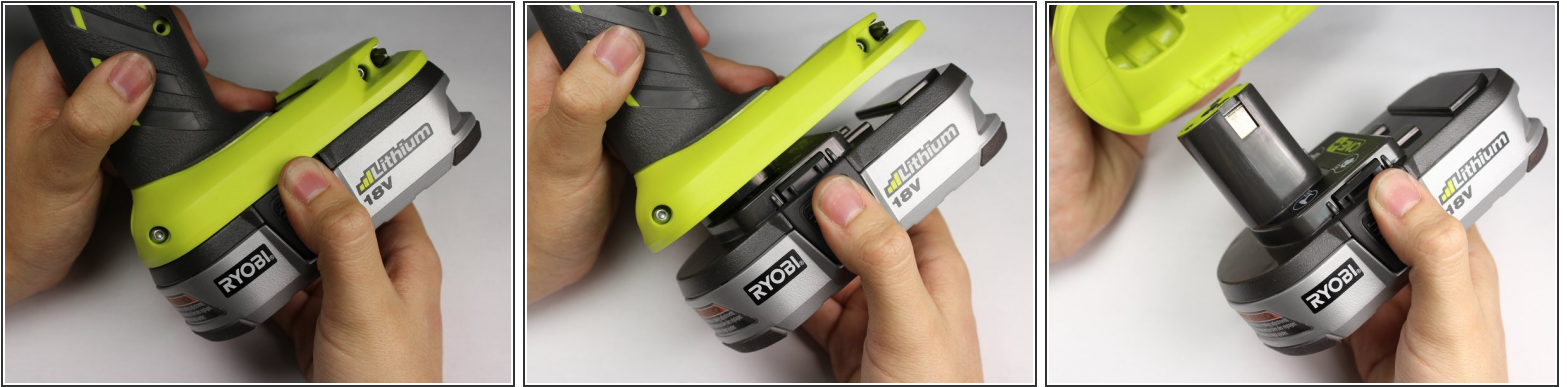
Step 1 — Battery

⚠ The battery can shock you. Only touch plastic, non-conductive components.

- Detach the battery unit from the drill body by pressing the battery release buttons on both sides of the unit and pulling outwards.

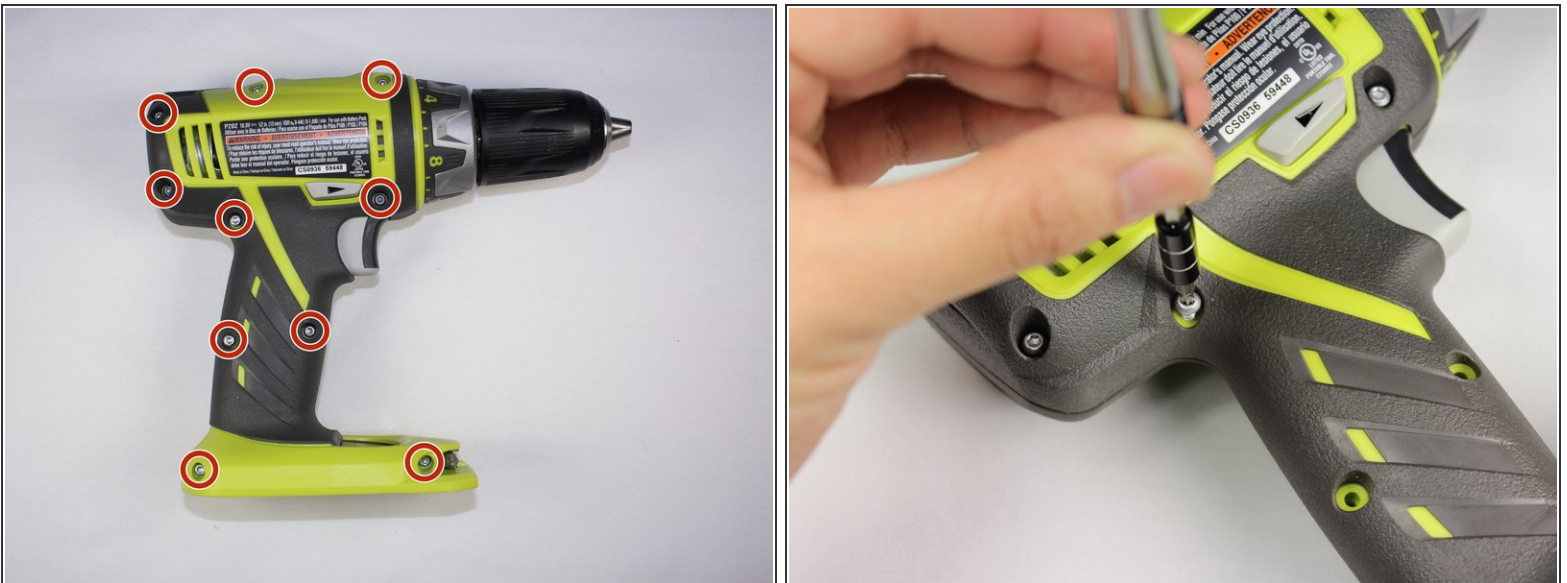
Step 2 — Right Side Case

- Use a Torx T10 screw driver to unscrew all ten 13.5 mm screws from the drill casing to gain access to the interior.

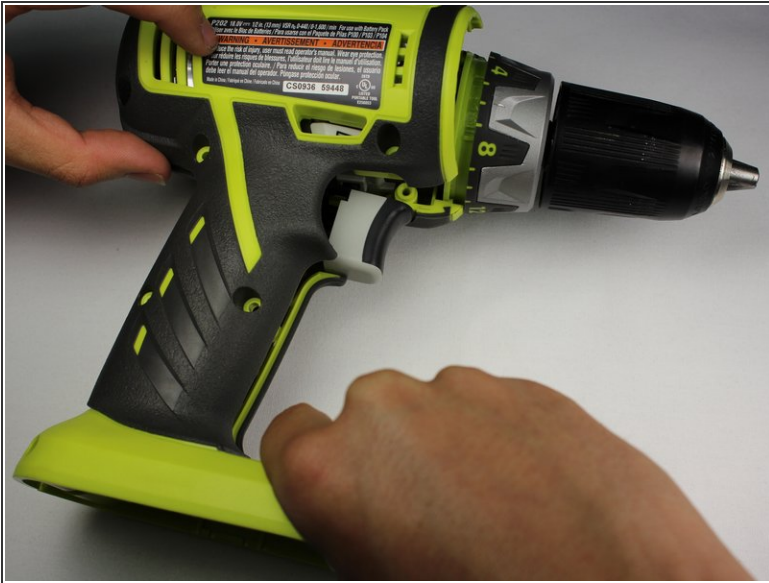
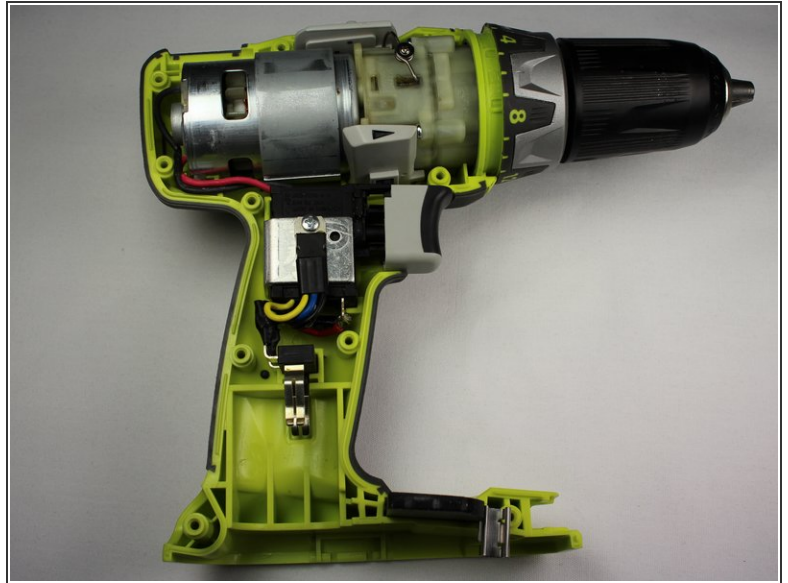
Step 3

- Gently lift the casing from the drill body.
 - Take the casing completely off the drill body to gain access to the interior of the drill.
- i** The Ryobi P202 casing has Part #: 200690001

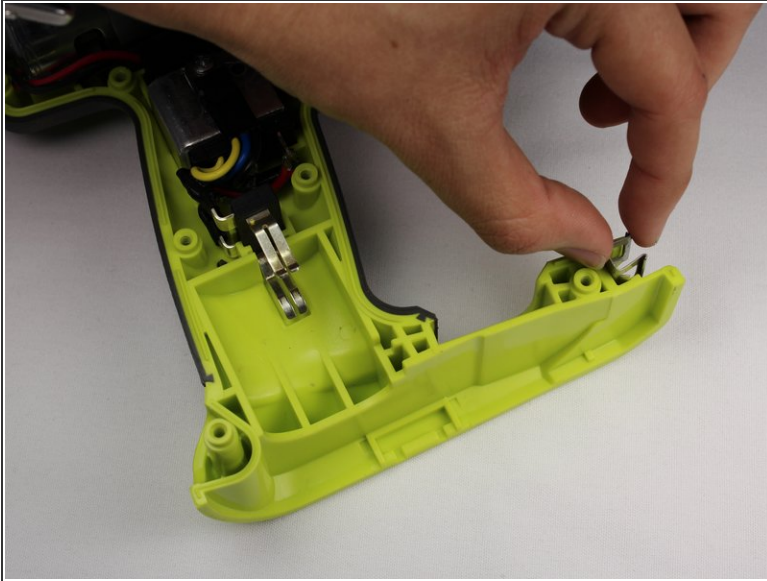
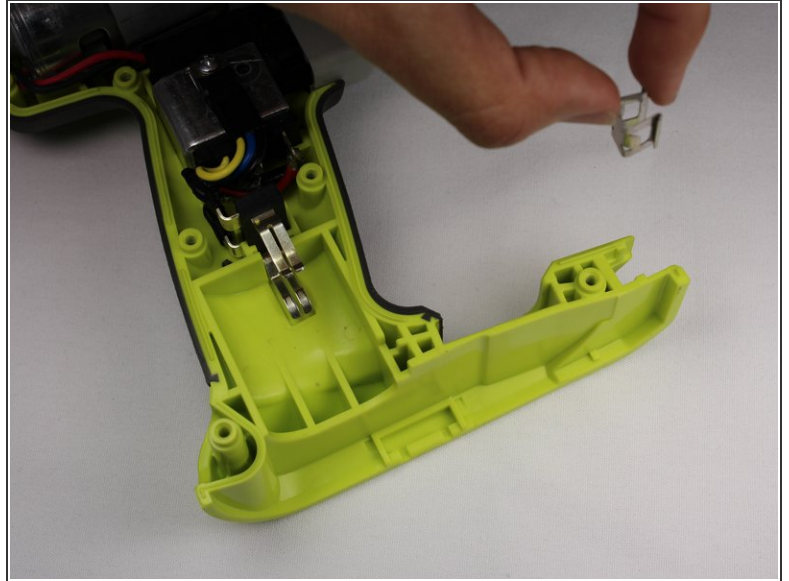
Step 4 — Bit Storage Clip

- Grip the bit-clip and gently lift up to remove it from the case.

i The bit-clip is Part #: 630206007
