Handset Microphone Replacement

This guides you through replacing a faulty microphone on your Sony SPP-A946 handset.

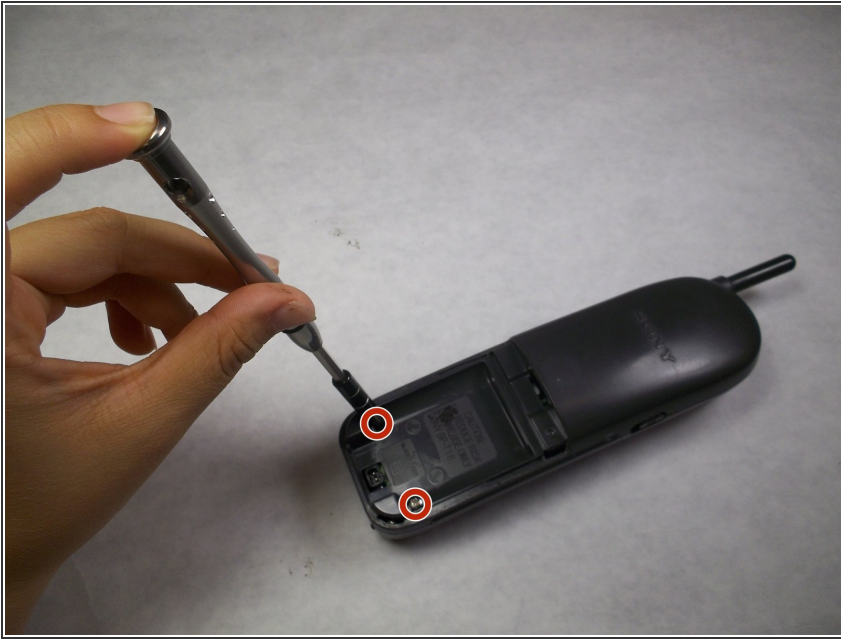
Step 1 — Handset

- After removing the BP-T18 battery pack, you will see two 11mm Phillips #0 screws located at the bottom of the phone. Remove both screws with a screwdriver.

⚠ Product is made of brittle plastic.

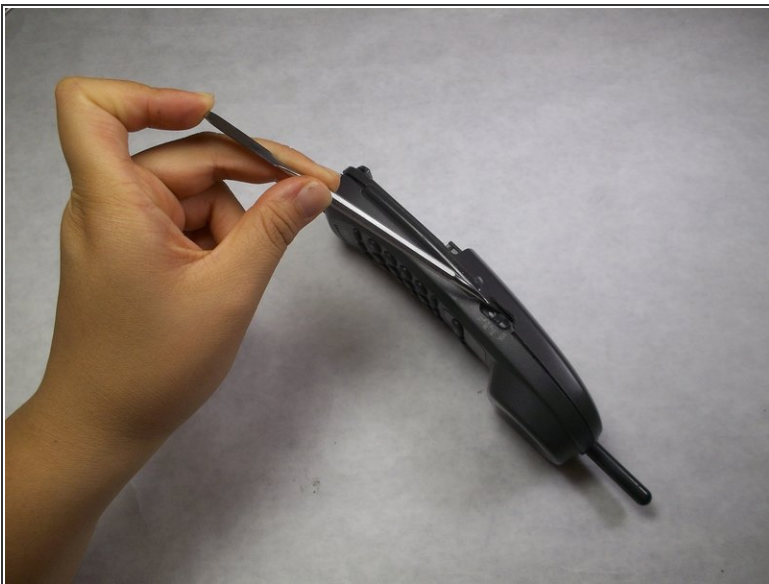
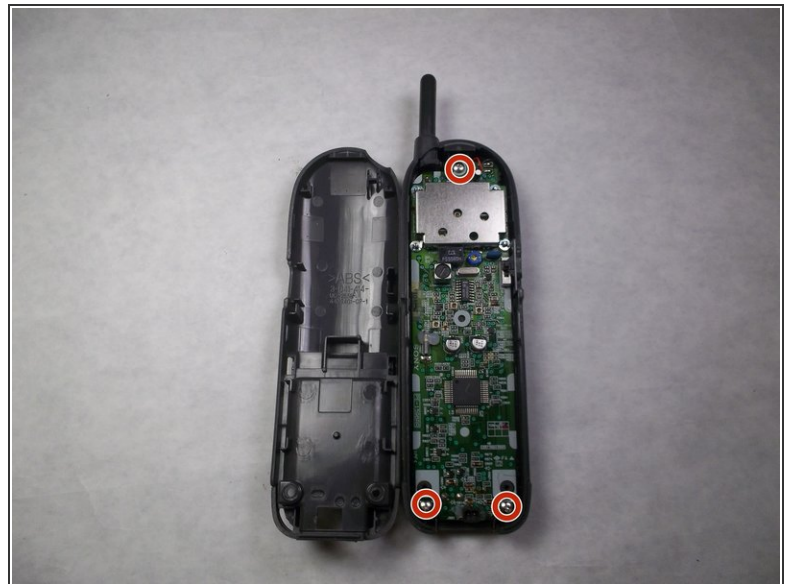
Step 2

- Locate an easy point of access for a spudger, and then slowly insert it into the gap and pry it open.
- ⓘ The opening should become bigger if you exert force at a 30 degrees angle.
- Increase the degree of slant until the back cover is completely removed.

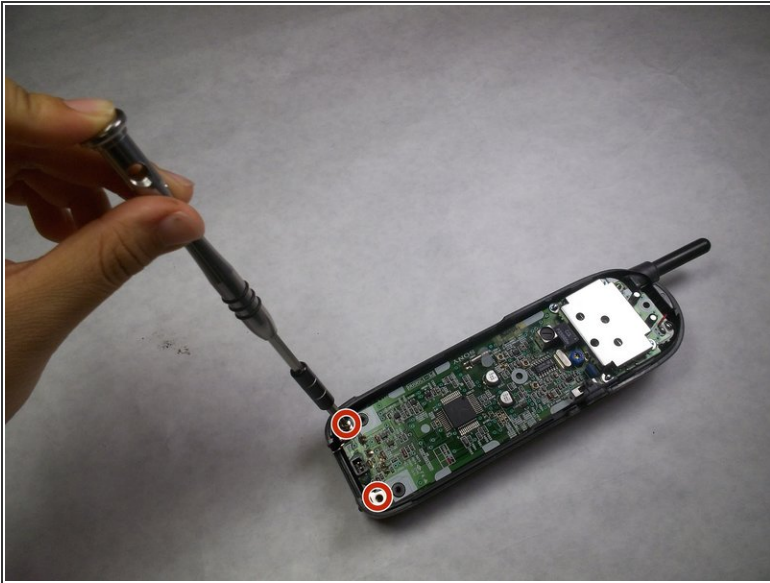
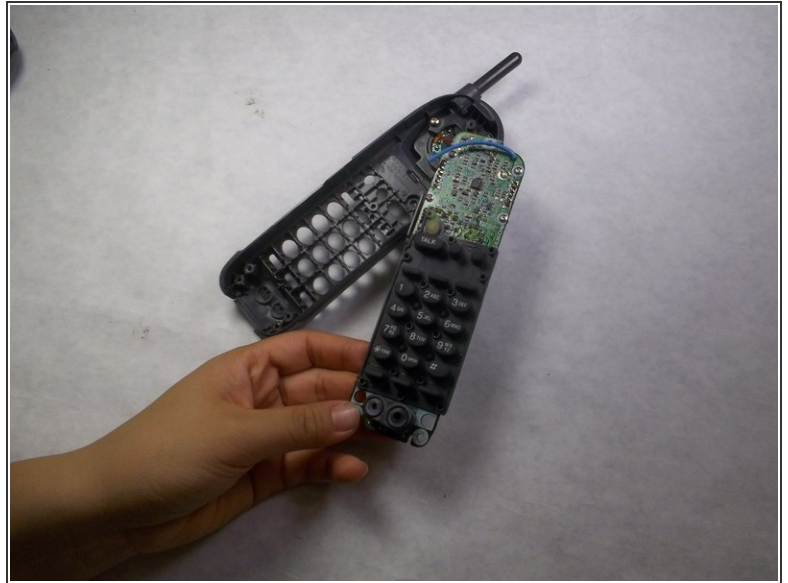
Step 3

- After removing the back cover, you will see 3 screws: one 7mm Phillips #0 screw at the top and two 11mm Phillips #0 screws at the bottom.
- Use a screwdriver to remove all 3 screws.

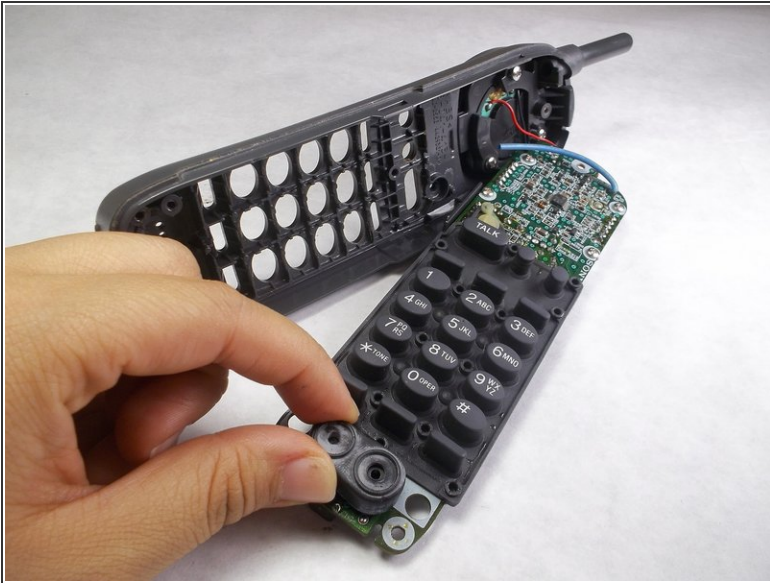
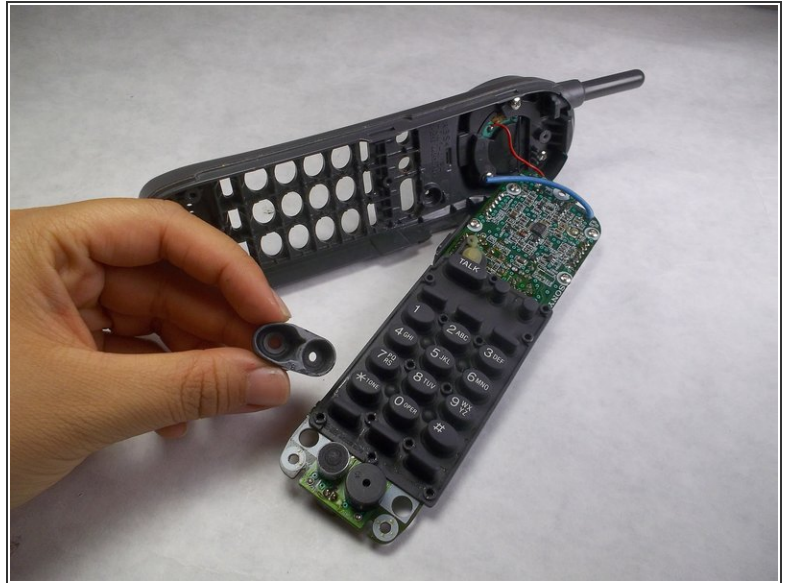
Step 4 — Handset Microphone

- i After disassembling the handset, you will see the inner components of the handset.
- Locate the rubber part towards the very bottom of the handset. This is the microphone with protective rubber cover.
- Remove the protective rubber cover. This may require a spudger.
- ! The microphone is exposed upon removal of the protective rubber cover. Avoid contact with water.

To reassemble your device, follow these instructions in reverse order.
