Garmin Edge 800 USB not connecting to PC

Garmin Edge 800 have a bad habit of not connecting to PC (not recognized by PC) or starting to a diagnostic screen after the USB port has been exposed to moisture. In this guide I will show you what is causing this malfunction and how to fix the problem.

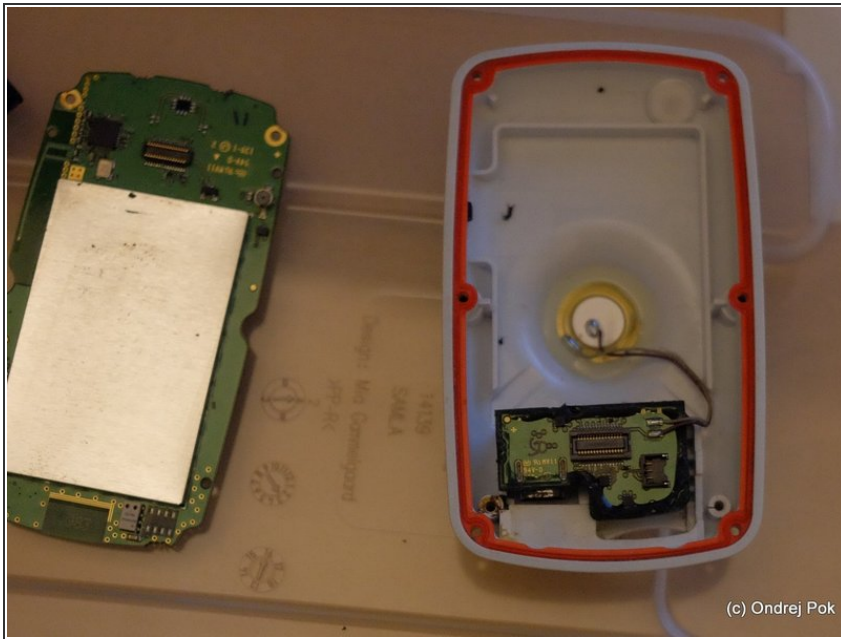
Step 1 — Open the device

- Disassemble your Garmin until you have the bottom half of the case like in the picture (if you're not sure how, look at youtube for a video on how to replace battery)
- It requires the correct size of Torx for the screws
- The main circuit board and battery is easily disconnected from the little board which is part of the bottom half of the case
- You may keep the processor board and LCD together

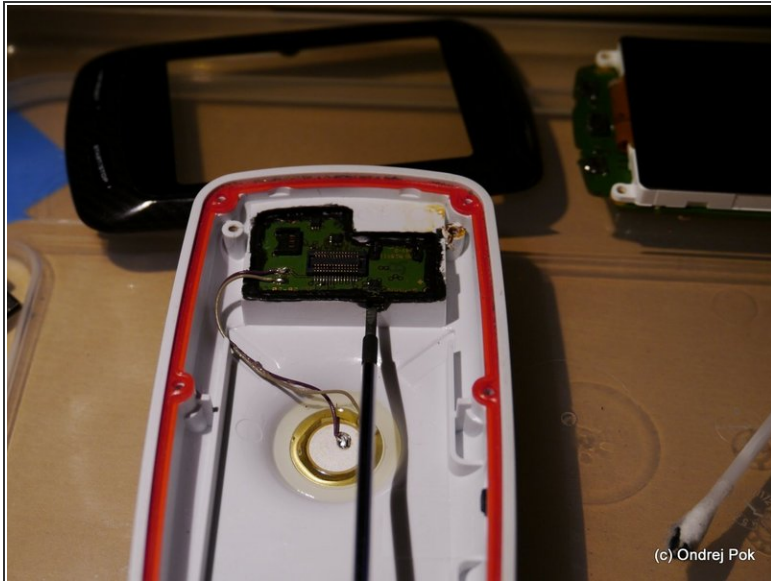
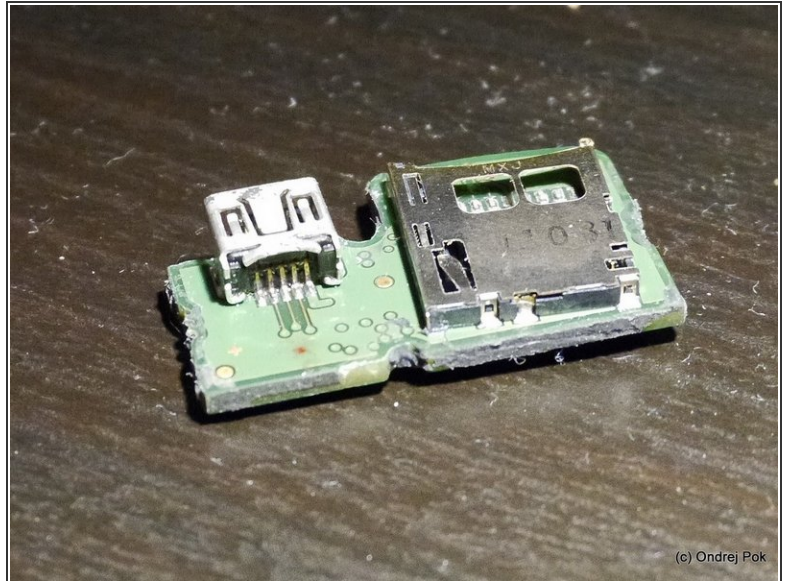
Step 2 — Remove small circuit board

- Desolder the 2 speaker wires from the circuit board (take a photo before you do so)
- Scrape away the sealant and remove the small circuit board with the USB port and SD card from the bottom half of the case
- In next step you will work only with the small USB / SD circuit board

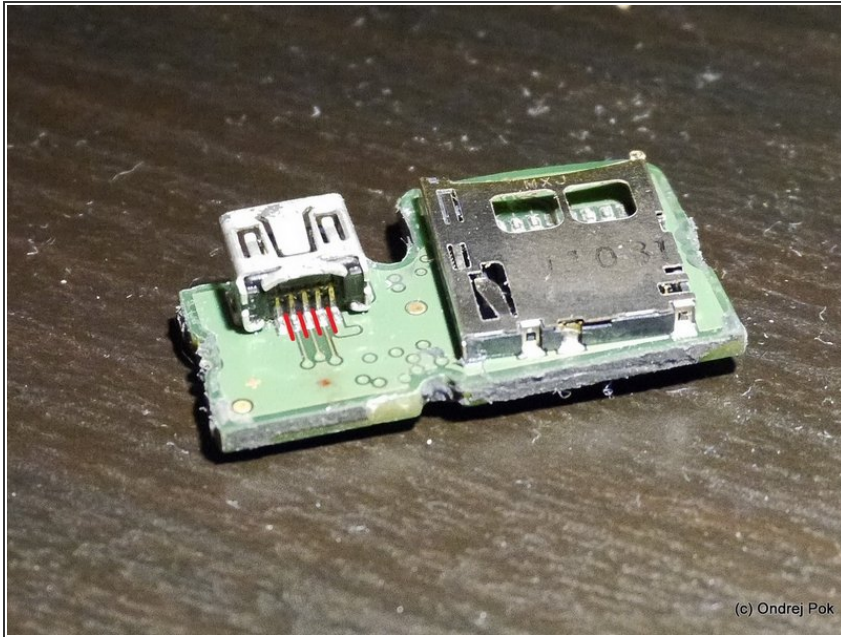
Step 3 — Fix the cause of the problem

- The actual cause why the USB stops working is that the tiny pins on the back side of the USB plug corrode
- As the wires corrode, they enlarge their volume, causing short between the wires
- I found it when I noticed in the service screen that the USB input voltage measured only about 3V
- To remove the corroded metal causing the short, take a sharp tool (could be sharp pointed tweezers or a needle) and scrape away the oxidized material from between the leads, as indicated by red lines in the picture
- brass wire brush or steel wool could also be helpful
- Apply plastidip on the pins to protect them from environment and to prevent them from creating short again

- After you put the USB / SD circuit board back into the bottom half of case, seal it with something like plastidip or silicone sealant.
- Resolder the speaker wires
- Clean the connectors with 100% alcohol or lighter fluid (naphta) to ensure good contact
- Then reassemble the whole unit
- Be gentle when tightening the torx screws, as the thread in plastic is quite easy to strip with too much torque (If you're curious how I know it, look closely at the pictures :)
