How to fix a Philips Sonicare DiamondClean HX9340 when it is getting less powerful or has a weak brush.

Follow this guide to fix Philips Sonicare DiamondClean HX9340 after it acting less powerful than previously or if it seems like a weak brush.

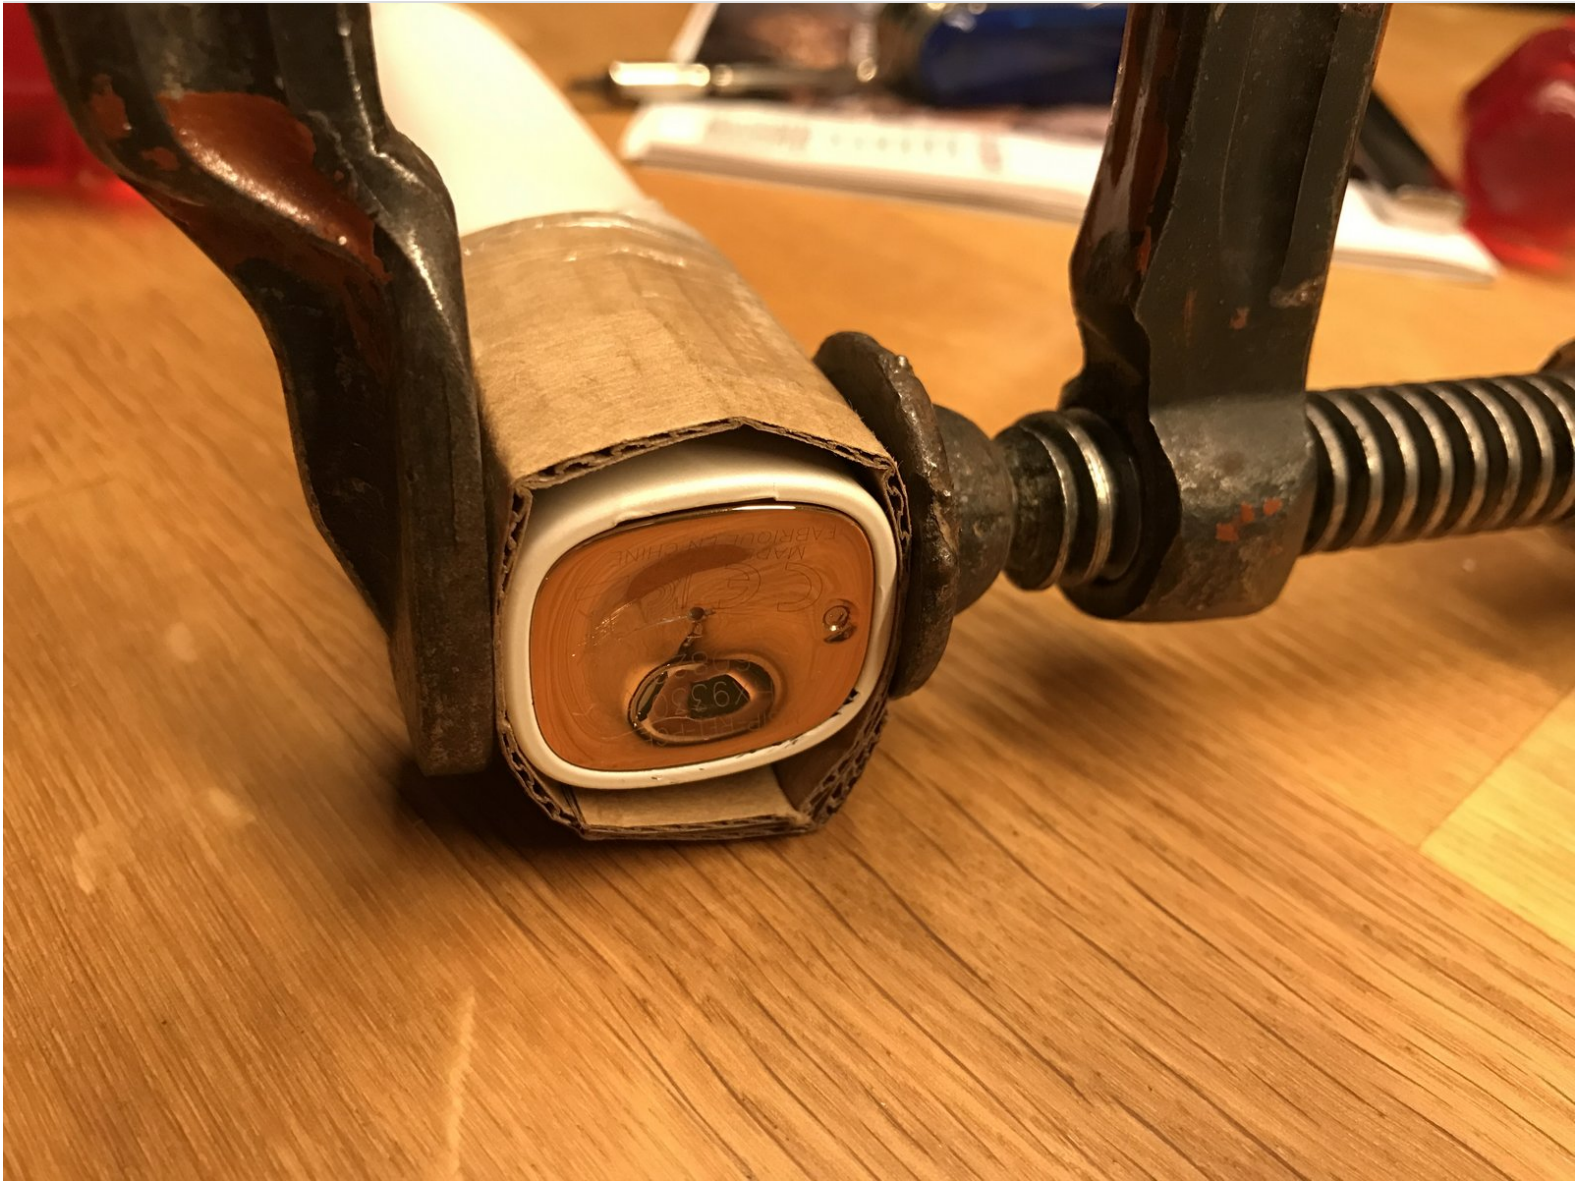
If your Sonicare is not as powerful as it used to be it could be because of a misalignment of the magnetic motor, e.g. if it's dropped. Philips built it like this on purpose and you need open the toothbrush and realign the magnetic motor.

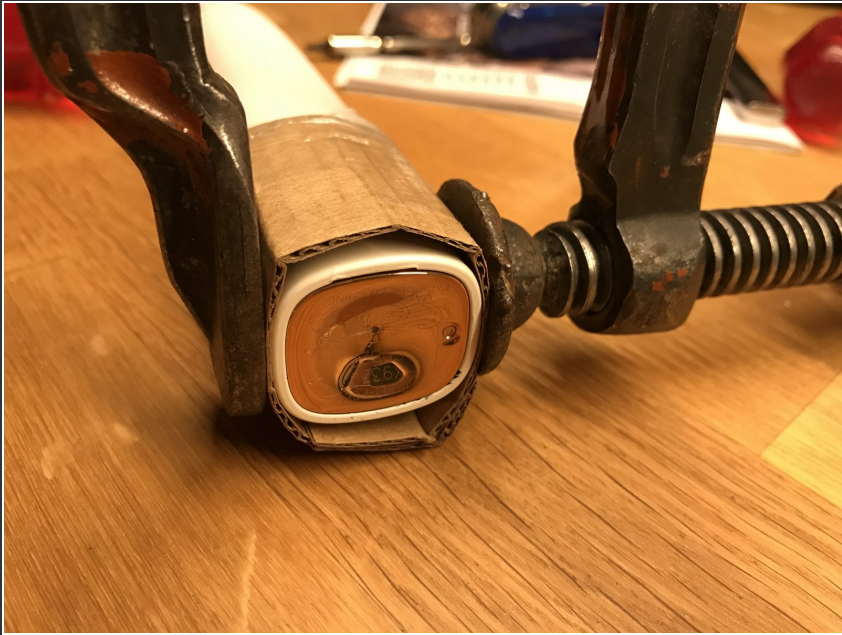
Step 1 — How to fix a Philips Sonicare DiamondClean HX9340 when it is getting less powerful or has a weak brush.

- First you need to open the toothbrush. This can be achieved by applying pressure to the lower end of the toothbrush which will allow the removal of the bottom cap.
- To protect the toothbrush from being mared by whatever tool is used, apply some cardboard or similar between the tool and the toothbrush
