SmartNav 4 false contact repair

When the unit shows erratic behavior or the device isn't installing programs properly, you may look for a shortcut between it's internal components.

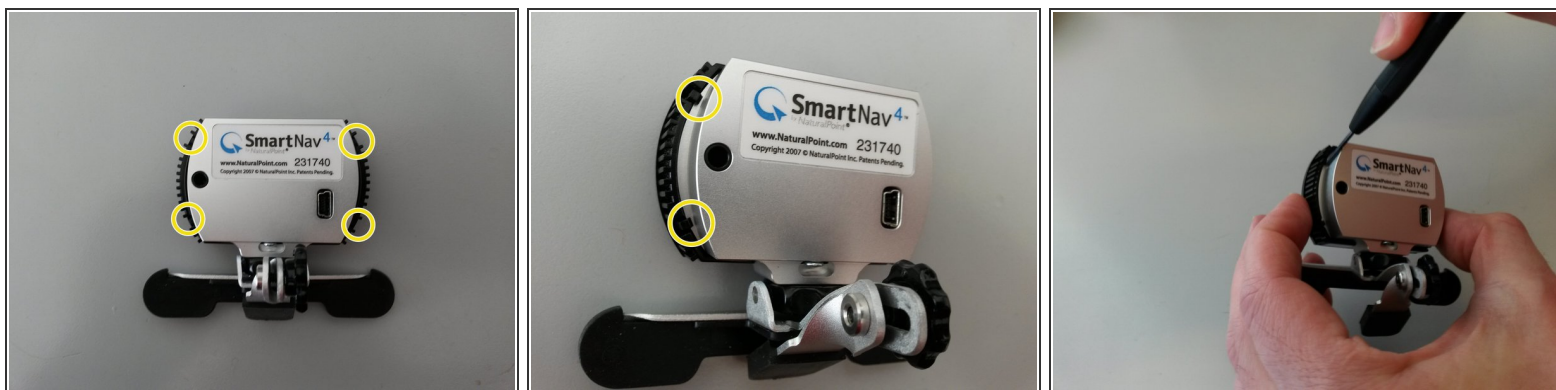
Step 1 — Device disassembly

- Gently open the four plastic tongues with a small slotted screwdriver, you need to keep the black and silver plastic gently pulled apart.
