Motorola Moto Z Repairability Assessment

Lenovo Moto Z repairability assessment performed on January 4, 2017.

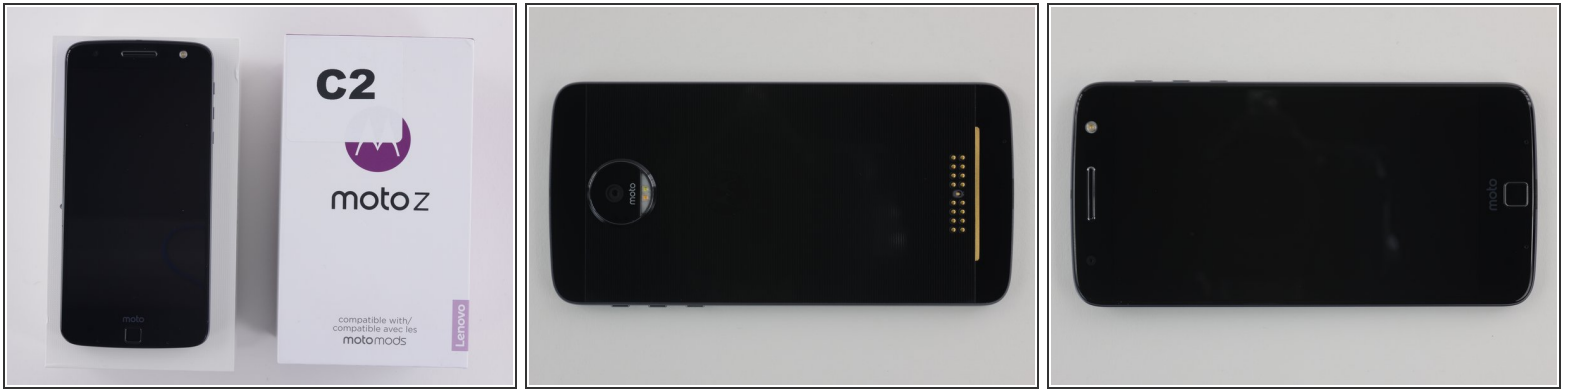
Step 1 — Reference front/back

- External expansion is possible with magnetically attached "Moto Mods." Easily swapped external battery packs may increase life of device.

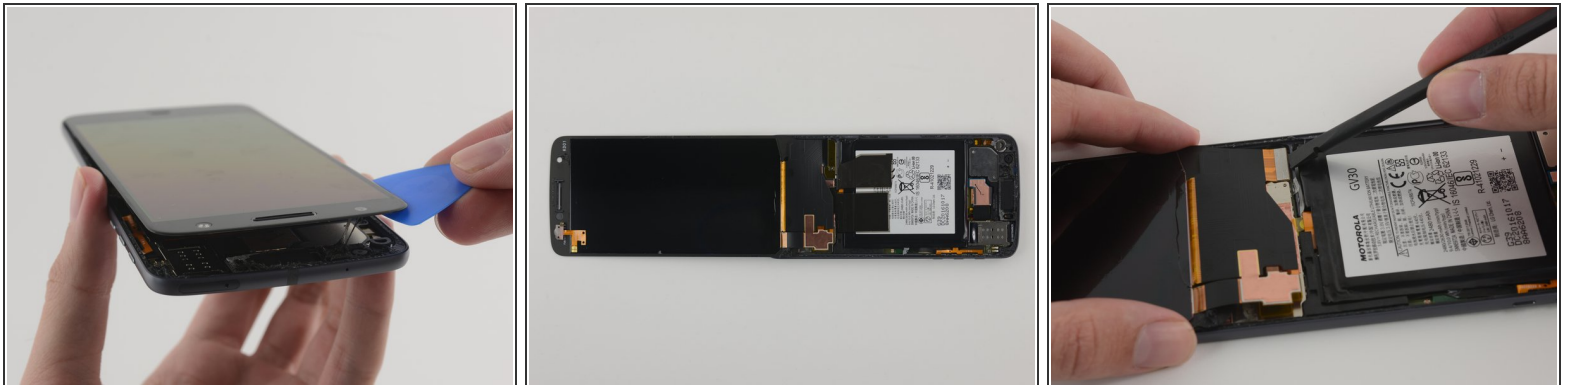
Step 2

- Sticky adhesive holds the display in place. Heat is required to soften the adhesive enough to pry up the display.
- ⓘ This adhesive is similar to adhesive found in waterproof devices like the iPhone 6s/7. This device is splashproof, not waterproof.
- The display cable is long enough to allow you to fold the display over completely, so you don't have to support it while disconnecting.
- However, it is very wide and hinders access to the battery connector—it's considerably easier to disconnect the battery after the screen is removed, which is not best practice.

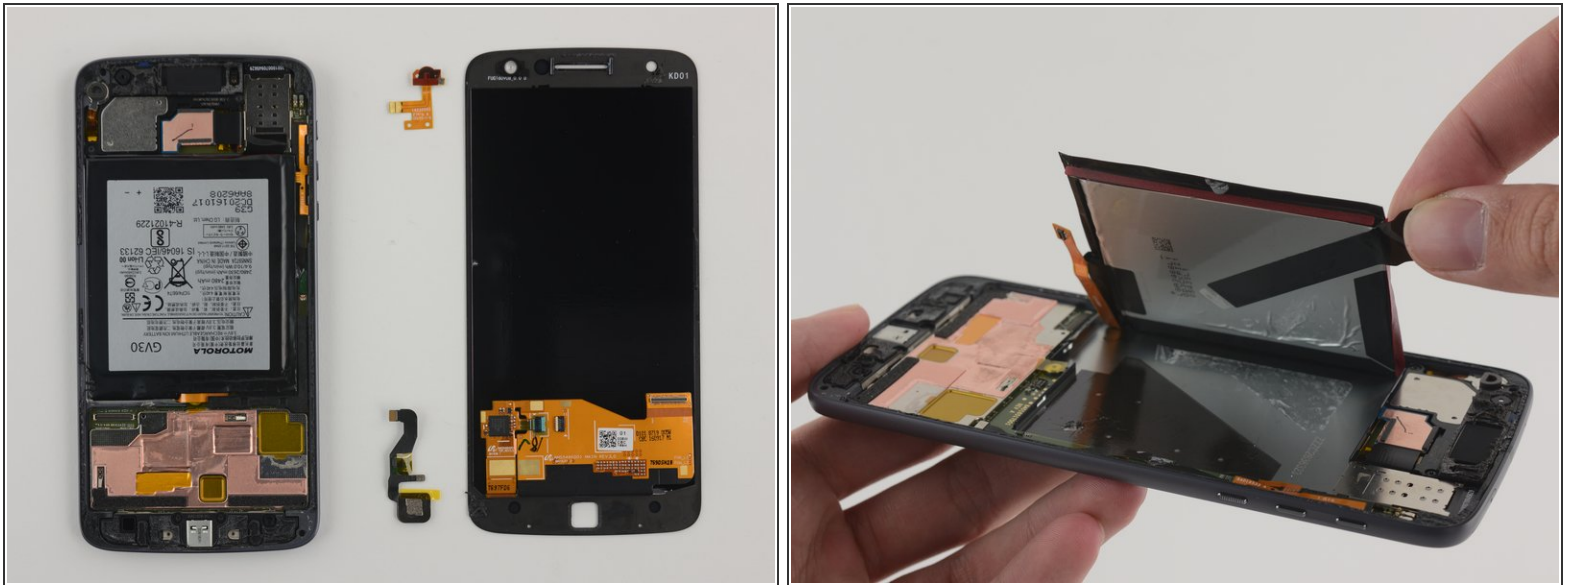
Step 3

- The fingerprint sensor button and ambient light sensor are held onto the back of the display assembly with strong adhesive.
- Heat was not needed, and both components can be easily reinstalled.
- ⓘ To test the most common repair, we remove the battery before proceeding.
- Battery has a plastic tab to aid in removal. The angle helps avoid ripping the tab off before it's free from the adhesive in the lower right corner.

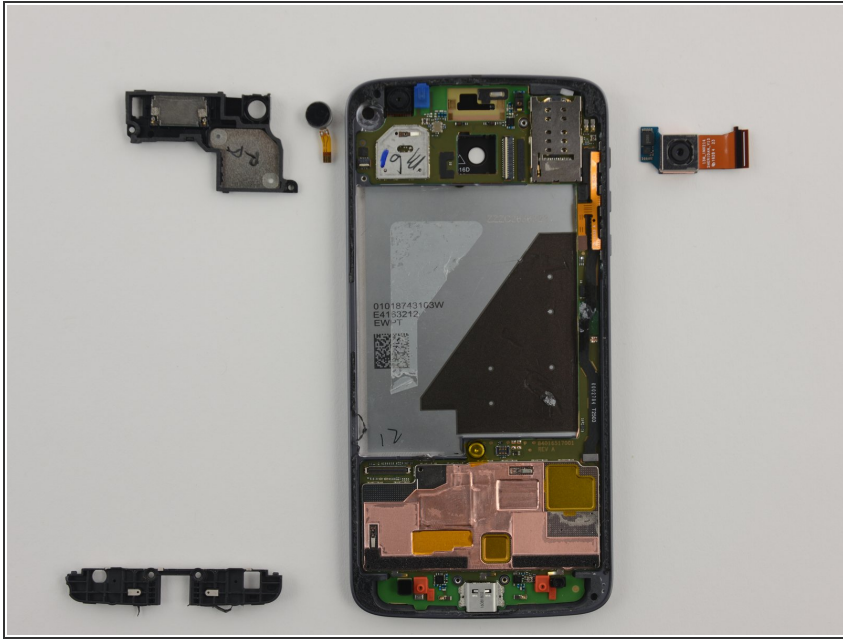
Step 4

- Vibrator and rear-facing camera are lightly adhered in place and can be removed now, (or before the battery is removed).
- Earpiece speaker assembly and lower bracket are held in place with Torx T3 screws and serve to hold down the top and bottom halves of the motherboard.

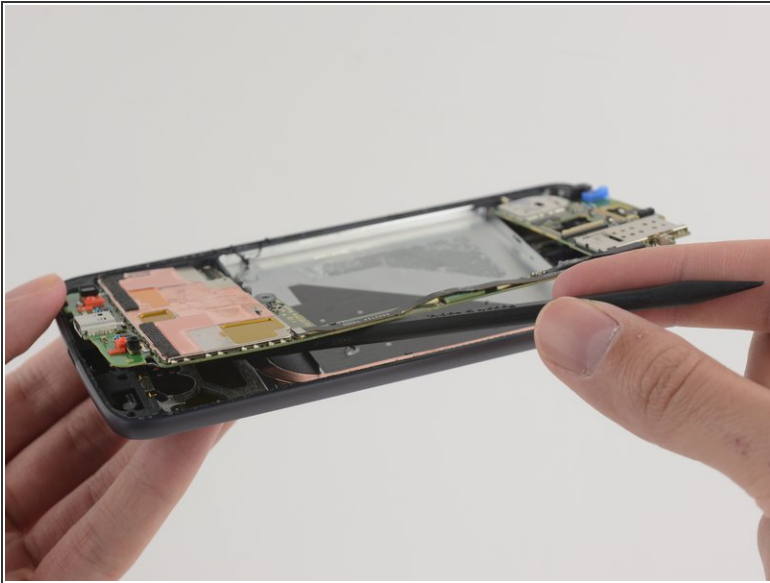
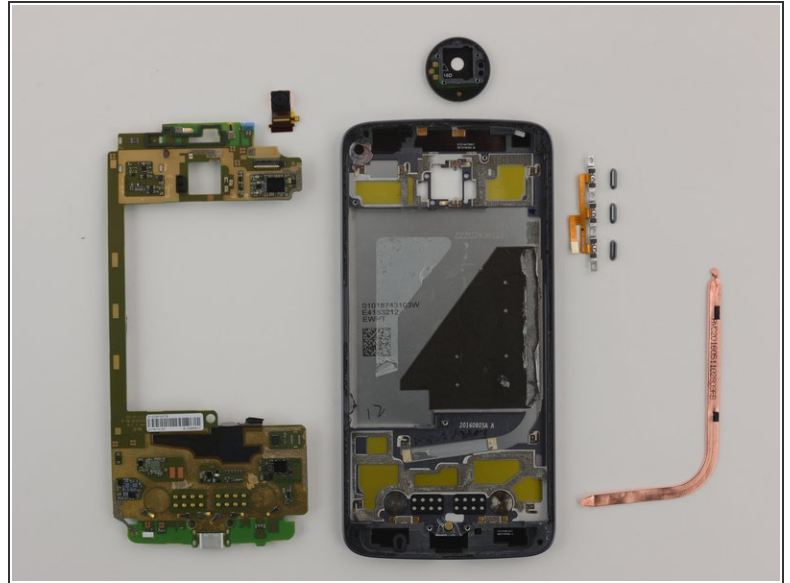
Step 5

- Removing the adhered motherboard
 - Motherboard as a single component is an expensive repair, especially with the commonly failing charging port soldered on.
- With the motherboard removed, the next layer of components can come out, including: front-facing camera, camera cover/LED flash assembly, heat pipe, button covers and switch ribbon cable.
