# Xiaomi Redmi Note 3 Repairability Assessment

Xiaomi Redmi Note 3 repairability assessment performed on January 10, 2017.

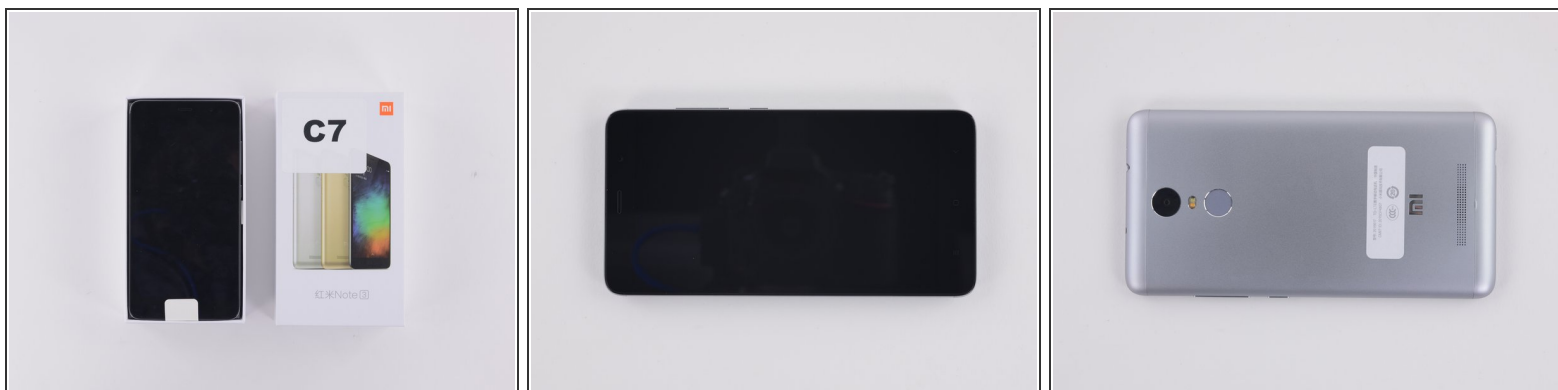
## Step 1 — Xiaomi Redmi Note 3 Repairability Assessment

- Exterior reference photos.

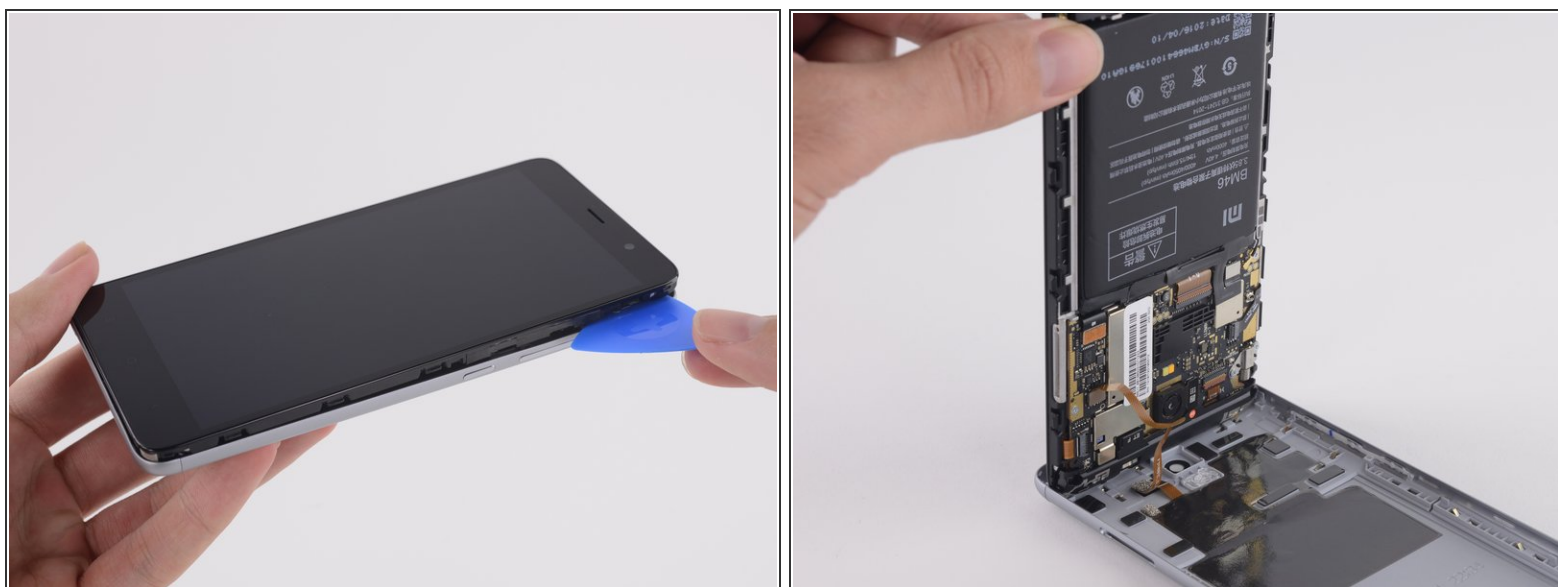
## Step 2

- There are no exterior screws. The top and bottom panels of the rear case are made of plastic, but cannot be separated from the rest of the case.
- Prying the body of the phone out of the rear case is fairly straight-forward, the plastic clips holding it are flexible enough to bend without breaking, and are not too strong.
- Fingerprint sensor cable connects the rear case to the interior of the phone, but is long enough that you can safely disconnect it without damaging it.

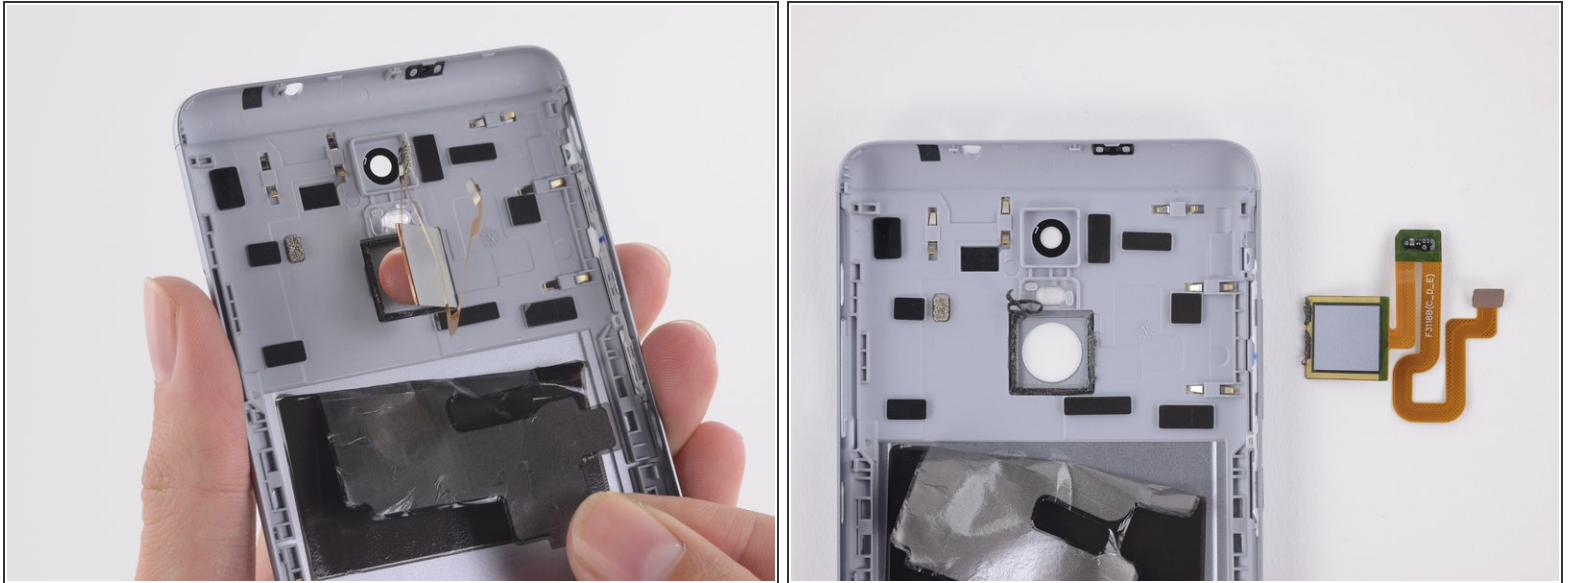
### Step 3

- Fingerprint sensor is the only component left in the rear case.
- Fairly easy to remove by pushing through the back of the case.

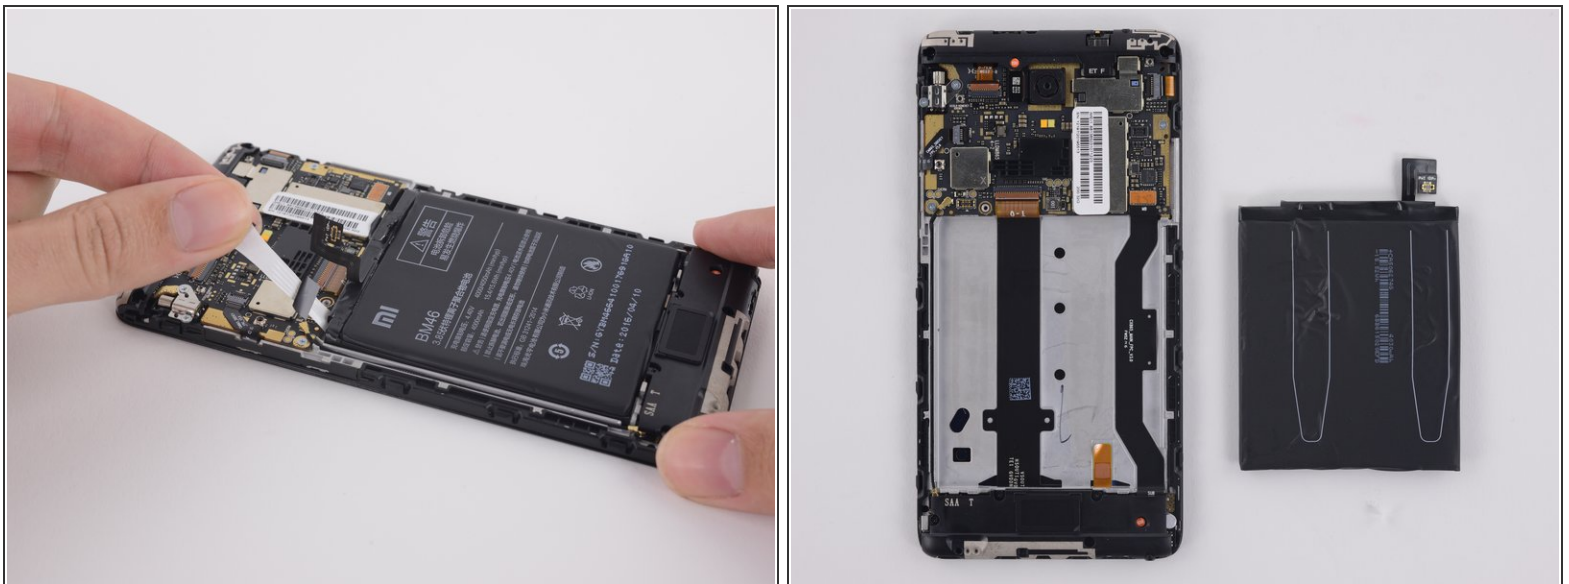
### Step 4

- Battery pull strips are awesome for easy battery removal.
- Battery removed.

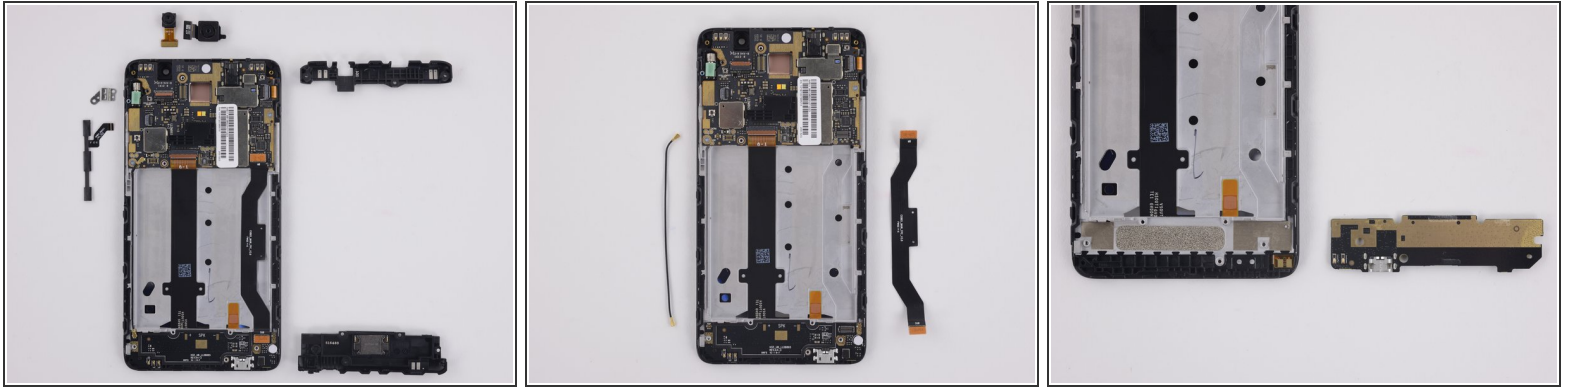
## Step 5

- First layer of removable components includes: loudspeaker assembly, antenna, buttons, vibrator bracket, front- and rear-facing cameras.
- Next out: interconnect cable and antenna interconnect.
- Next out, daughterboard with charging port.

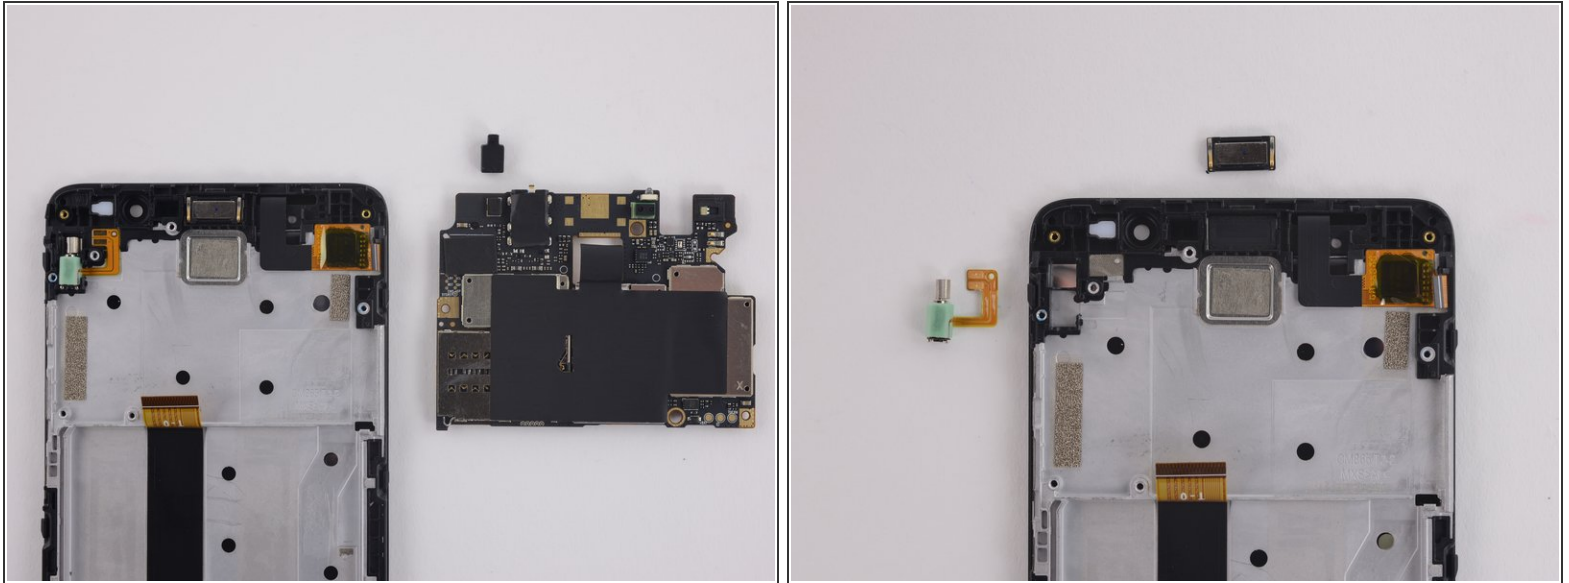
## Step 6

- Motherboard removal, the only component removed from the motherboard is a rubber duct for the microphone.
  - The main board is pretty minimal, but the headphone jack is soldered on, making jack replacements expensive.
- Final components off of the display assembly are the vibrator and earpiece speaker.
- The fused, midframe-mounted display assembly is last out, making fixing a broken screen a more expensive and time consuming repair.

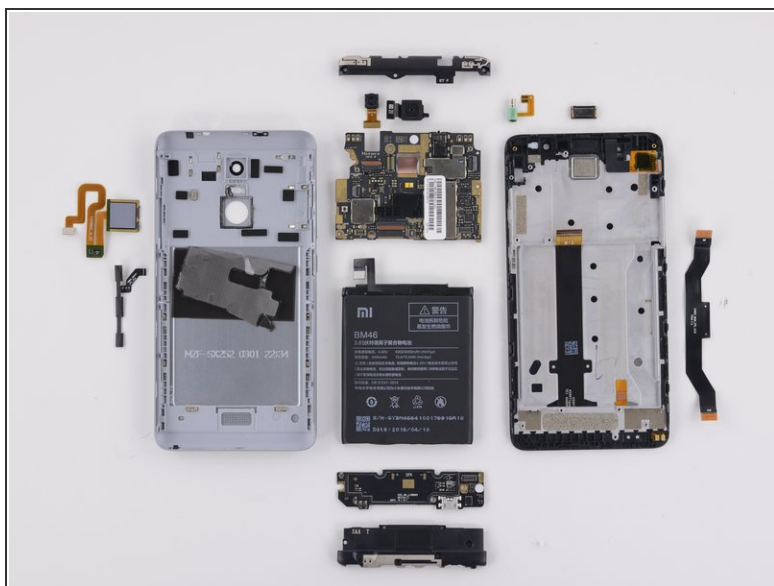
## Step 7

- The Xiaomi Redmi Note 3 earns an **8 out of 10** on our repairability scale (10 is the easiest to repair):
  - Despite no external screws, the rear case is fairly easy to remove.
  - Battery is easy to access and remove.
  - Modular design with charging port on its own daughterboard means many components can be independently replaced.
  - Display assembly is a single fused component, that requires disassembling the entire phone to replace.
  - Manufacturer does not provide user-accessible repair documentation.
