# Huawei MediaPad T2 Repairability Assessment

Huawei MediaPad T2 7.0 Pro repairability assessment on January 4, 2017.

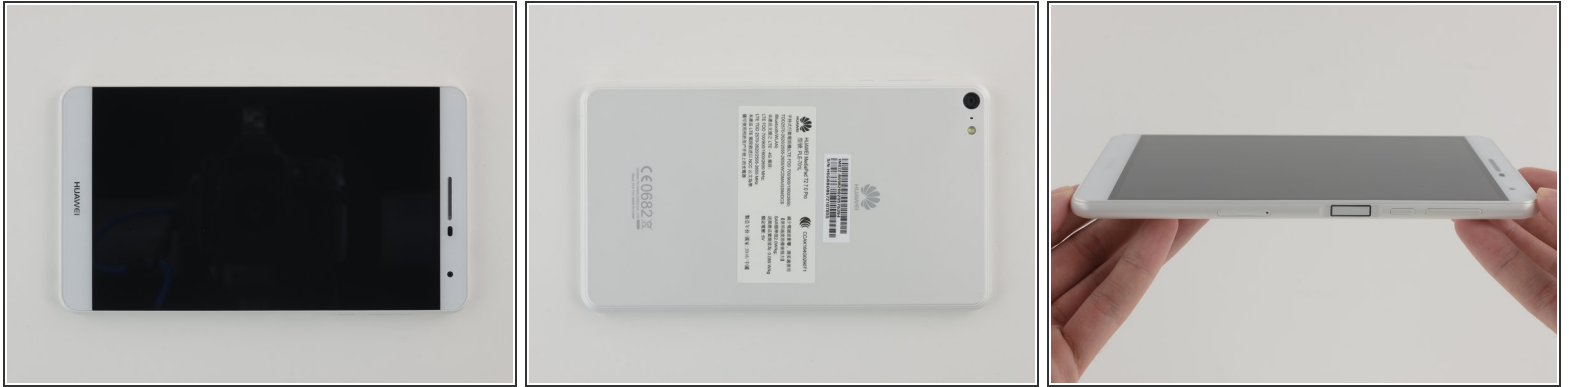
## Step 1 — Huawei MediaPad T2 Repairability Assessment

- Front/back and fingerprint sensor.
- Fingerprint sensor is solid-state, and less likely to fail than a button.

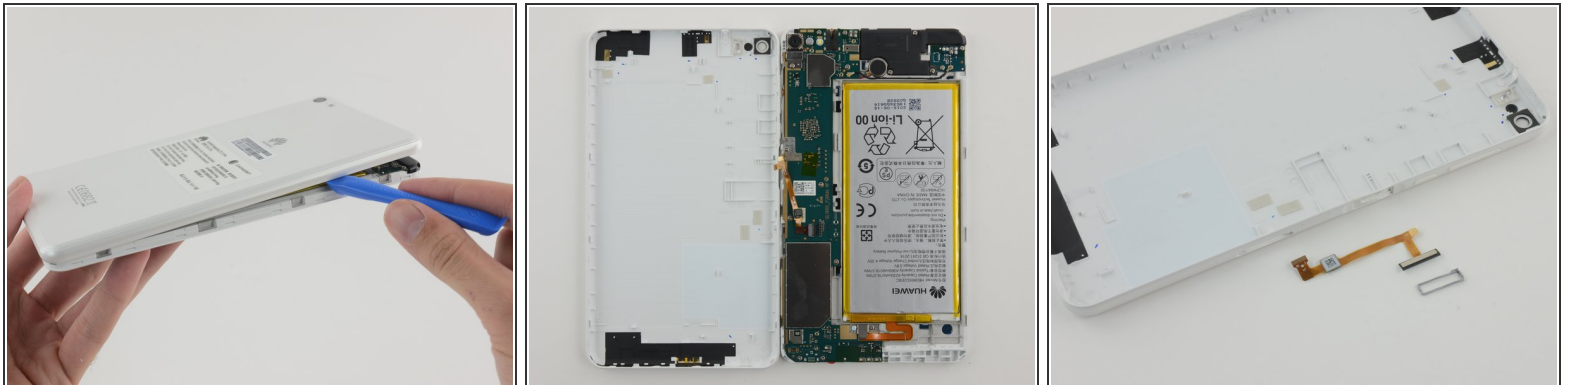
## Step 2

- Entry method is to remove the rear bathtub case, even though that's not very evident and the seal is extremely tight for opening tools.
- The rear case is soft plastic and may be damaged when removed.
- Fingerprint sensor and its cable connect the two halves, but there's some slack so it's not awful.
- The fingerprint sensor and its metal frame are very securely adhered to the rear case. They can be removed, but not without deforming the case.

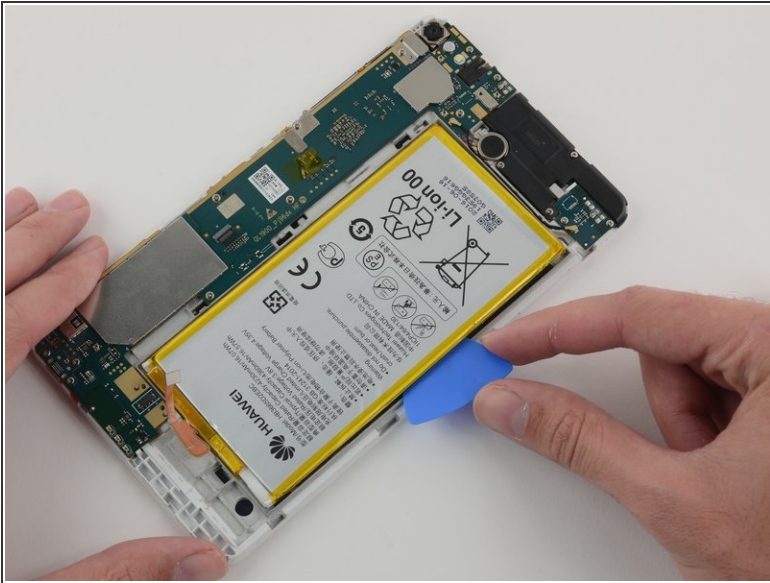
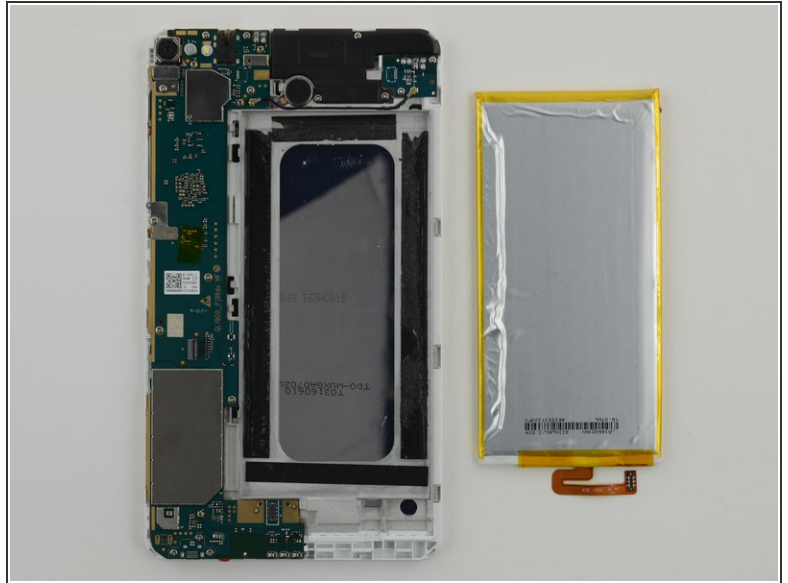
### Step 3

- Nasty strong adhesive secures the battery, no pull tabs. Prying and acetone were used to soften/cut the adhesive.
- Battery rests against the back of the display assembly, the gap in the midframe is ringed by four pieces of thick tape.

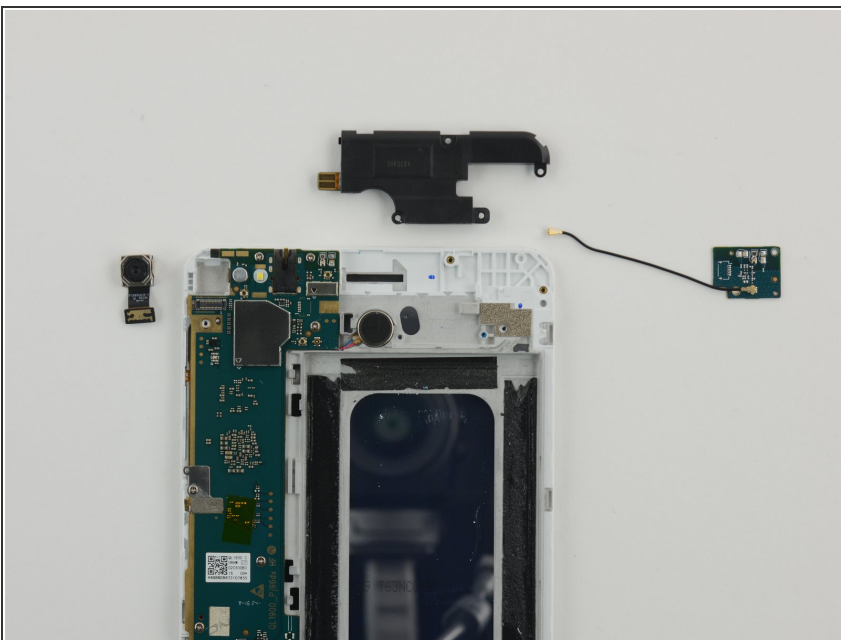
### Step 4

- Layer of components removable upon opening: rear-facing camera, speaker assembly, antenna interconnect board.

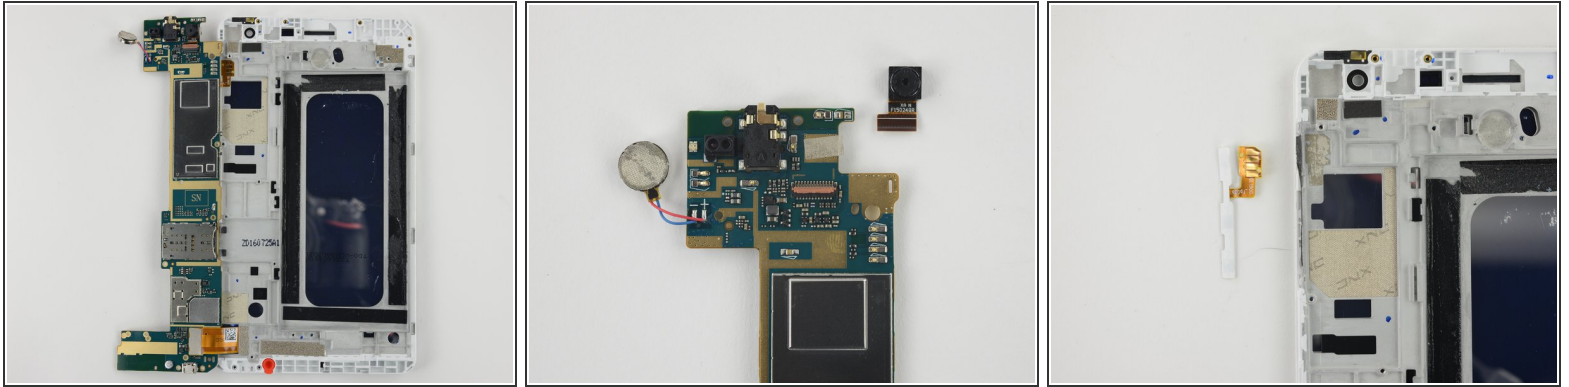
## Step 5

- Display connector is on the back side of the motherboard, with plenty of slack to flip the board over to disconnect.
- Soldered pancake vibrator and removable camera.
- Button cable can be removed after the motherboard.

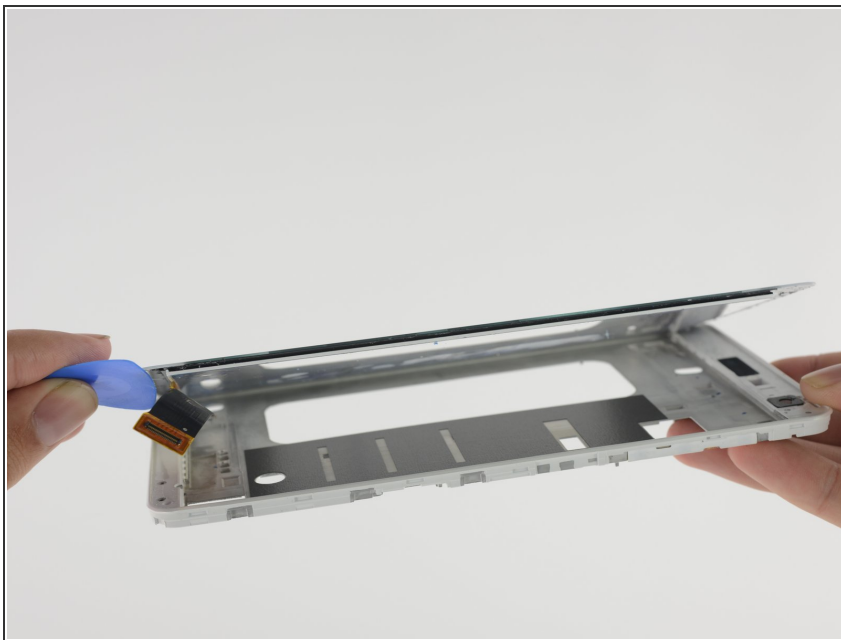
## Step 6

- The display assembly (glass+display) is very strongly adhered to the display frame. Removing it will be difficult, and will require replacement adhesive.

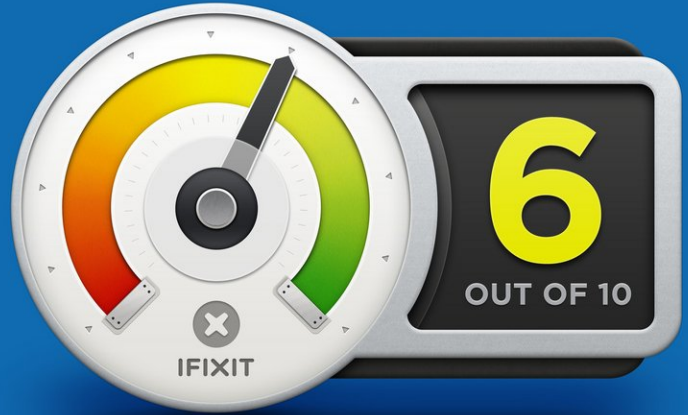
## REPAIRABILITY SCORE:

- The Huawei MediaPad T2 earns a **6 out of 10** on our repairability scale (10 is the easiest to repair):
  - Rear case is secured by clips, not glue, and is flexible enough to remove fairly easily.
  - Non-proprietary Phillips screws used throughout.
  - Battery is held in place with excessive adhesive. A hole in the midframe means prying the battery out may risk damaging the back of the display.
  - Charging port is soldered to motherboard, increasing cost of a common repair.
  - Manufacturer does not provide user-accessible repair documentation.
