# Amazon Fire Tablet (5th Generation)

## Repairability Assessment

Repairability assessment for the Amazon Fire Tablet, 5th Generation performed on January 5, 2017.

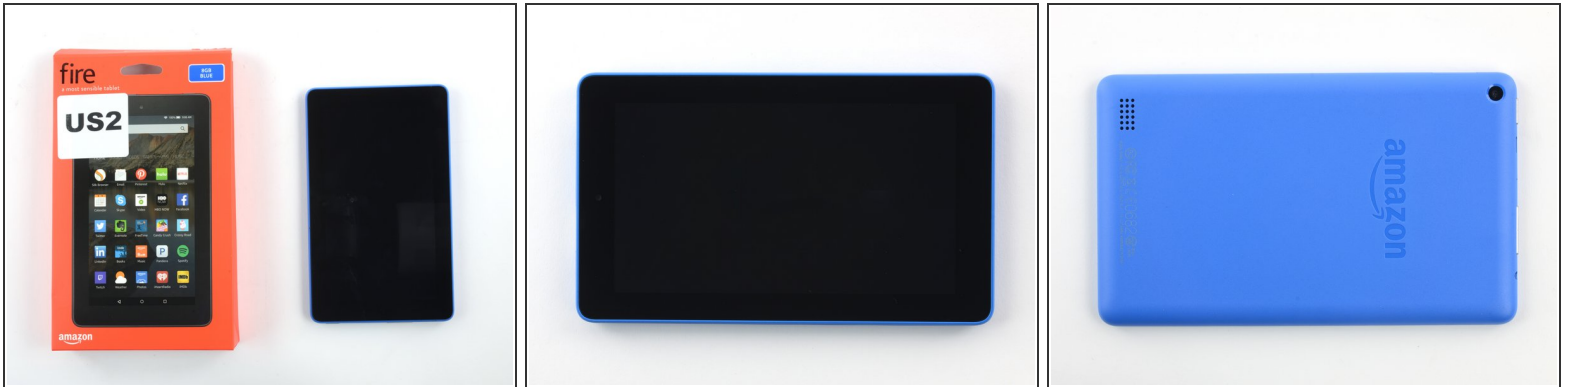
## Step 1 — Amazon Fire Tablet (5th Generation) Repairability Assessment

- Front and back reference shots.

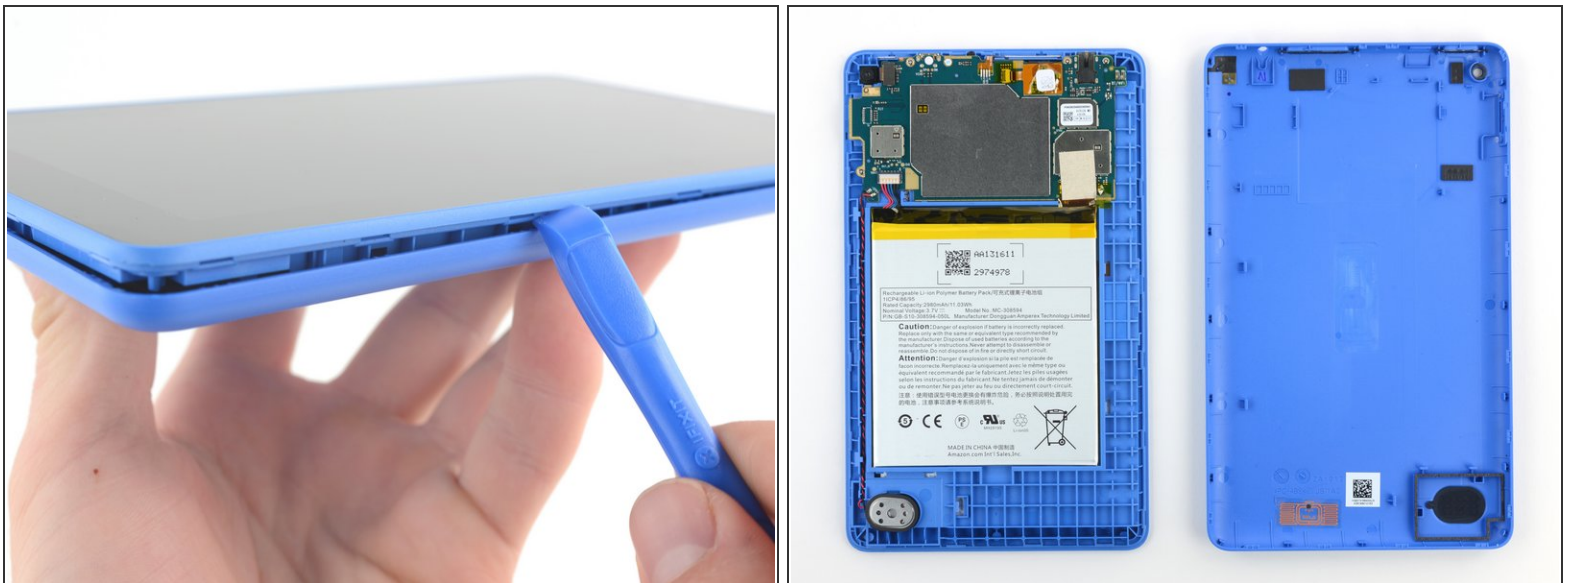
## Step 2

- There are only clips holding the assembly together. No adhesive makes for much easier device access.
- The plastic back cover comes off to reveal the battery, motherboard, and display hiding on the other side.
- We can also see smaller components, including a speaker and a camera.

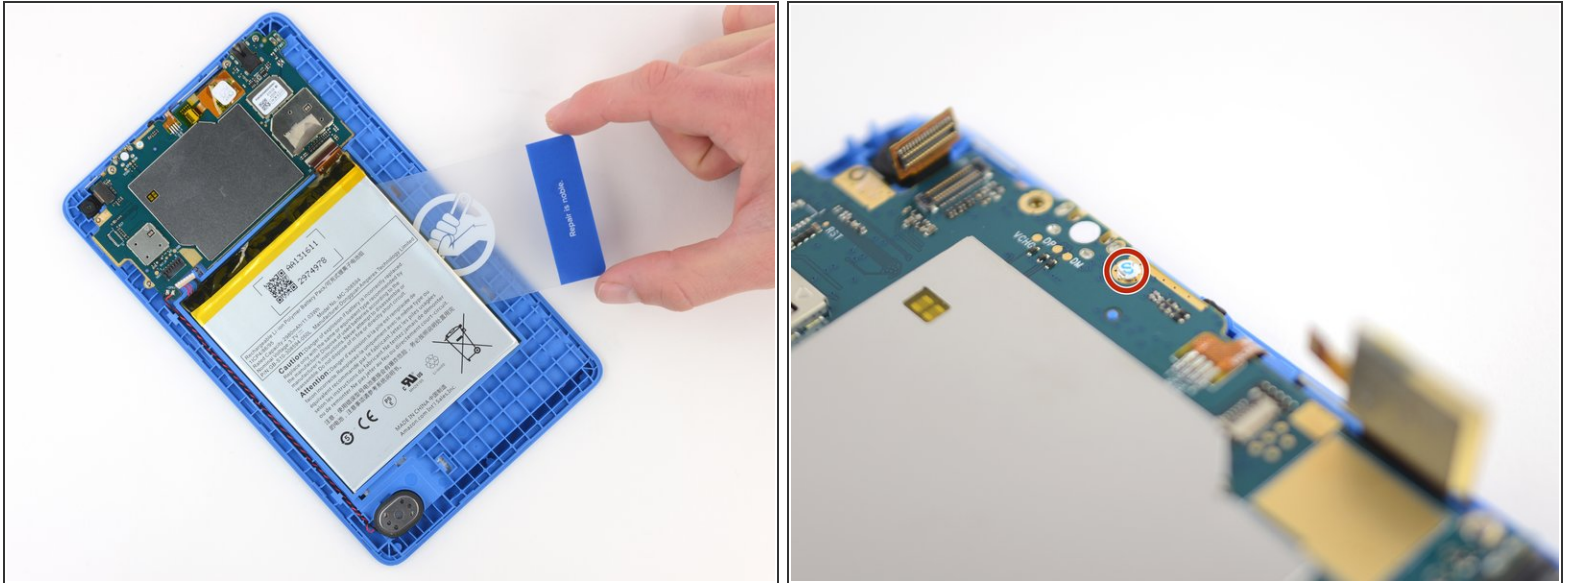
## Step 3

- This battery isn't super easy to remove. It's held in with several adhesive strips that require force to separate.
- We use a card to fight the adhesive and we can pry the battery out with a bit of effort.
- At the top of the motherboard there's a little tamper evident sticker.

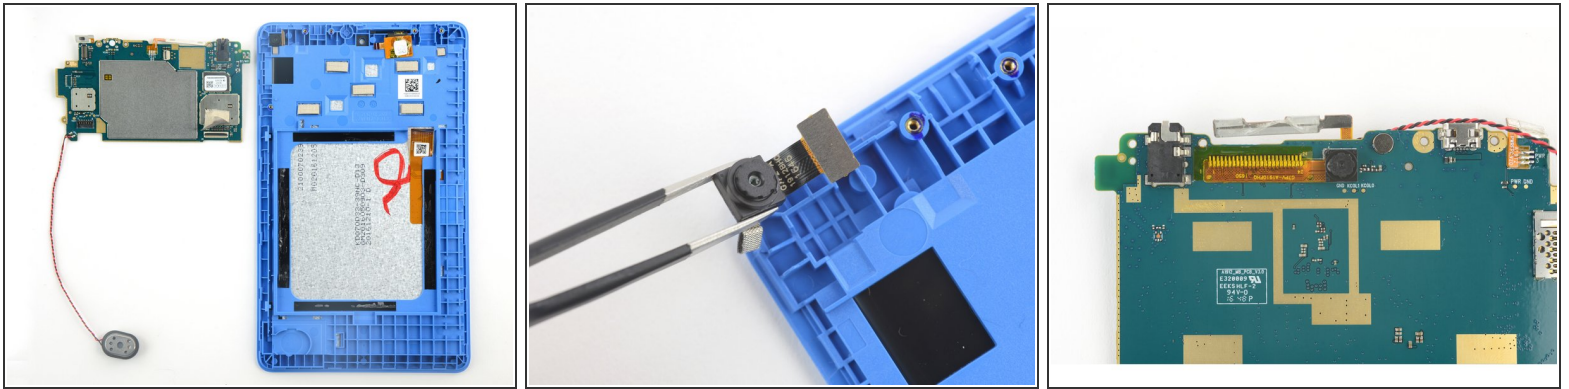
## Step 4

- We can remove the motherboard after removing five Phillips screws, and disconnecting two ZIF and two press connectors.
- Front-facing camera is modular and easily pops out.
- Rear-facing camera is soldered to the board and is not going anywhere.

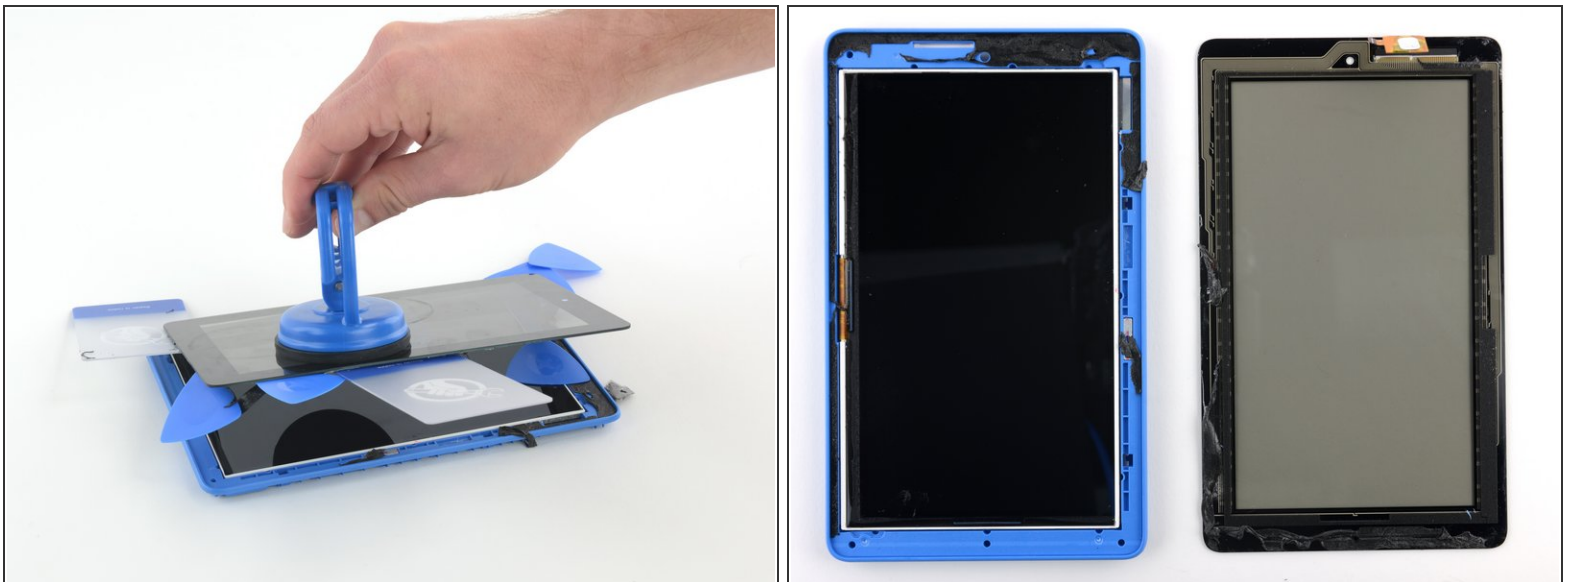
## Step 5

- Just the display assembly's left. How hard is a digitizer replacement?  
 ⓘ Hard.

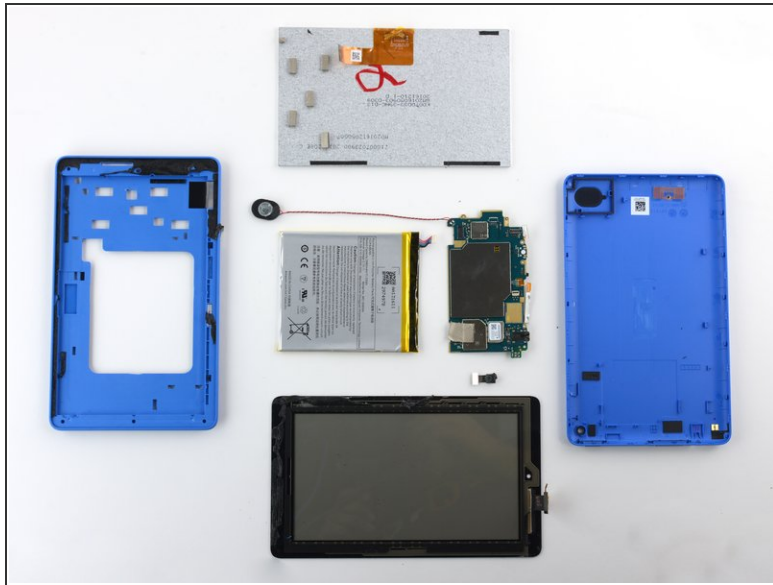
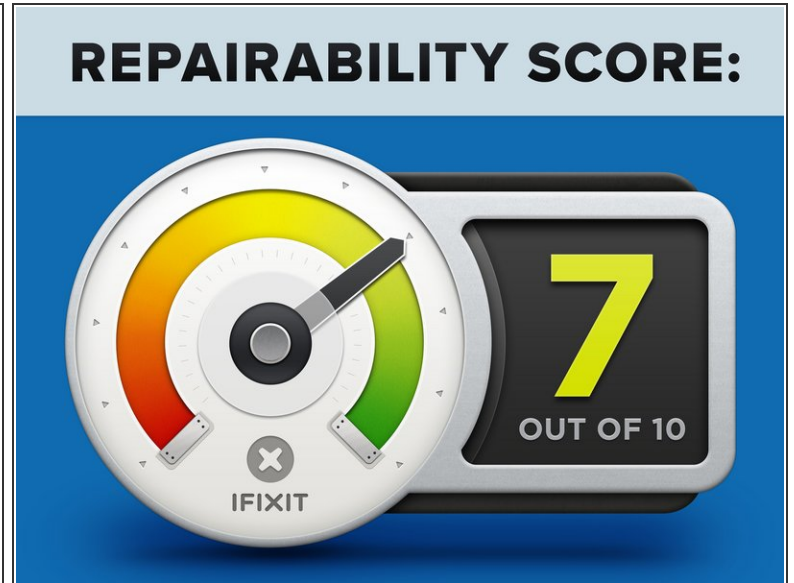
## Step 6

- The Amazon Fire Tablet earns a **7 out of 10** on our repairability scale (10 is the easiest to repair):
  - The plastic case assembly is held together by clips and no adhesive, and opening only requires prying with an iFixit opening tool.
  - The digitizer and LCD panel are not fused together.
  - All of the screws in the device are Phillips screws.
  - The battery is modular, but it is held in place by somewhat stubborn adhesive.
  - Removing the digitizer and LCD panel requires fighting through some very resilient adhesive.
  - Manufacturer does not provide user-accessible repair documentation.
