# Amazon Fire Tablet (5th Generation) Repairability Assessment

Repairability assessment for the Amazon Fire Tablet, 5th Generation performed on January 5, 2017.

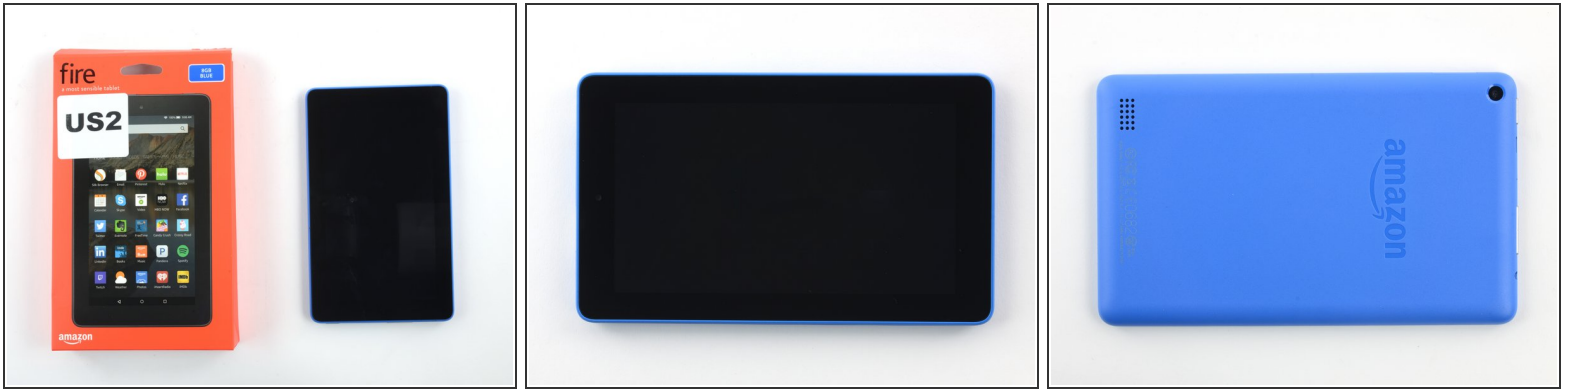
## Step 1 — Amazon Fire Tablet (5th Generation) Repairability Assessment

- Front and back reference shots.

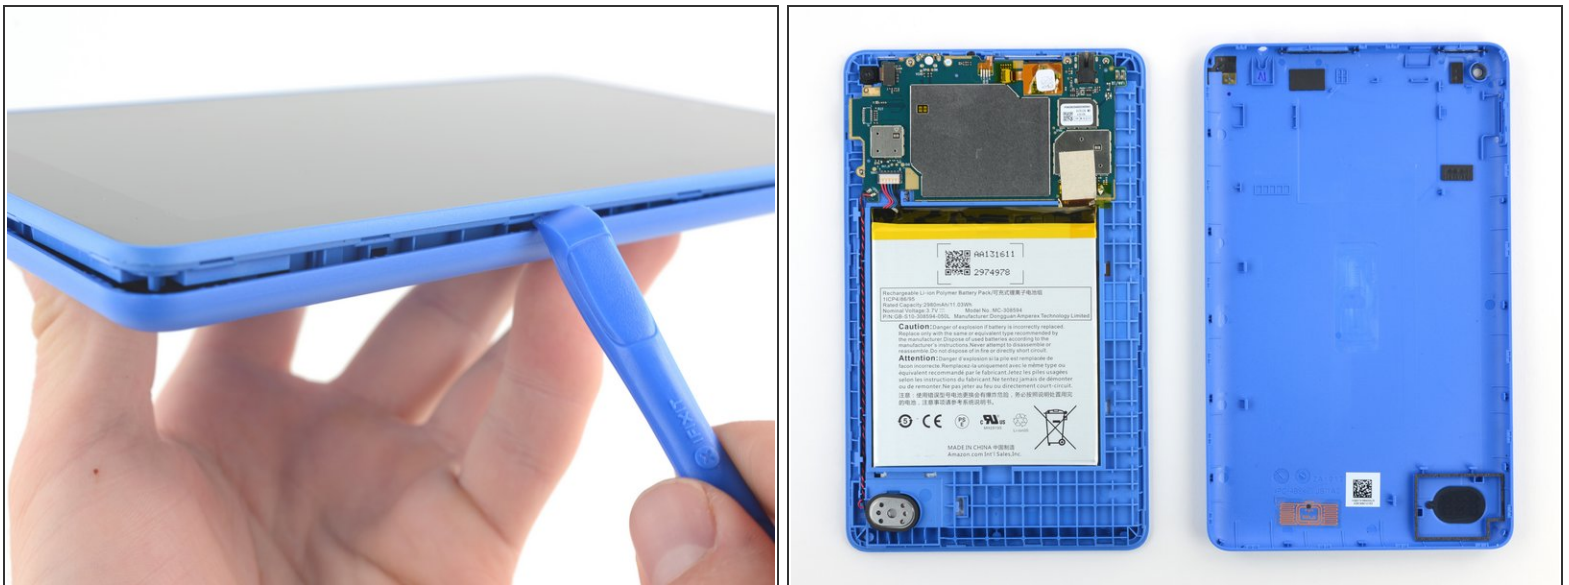
## Step 2

- There are only clips holding the assembly together. No adhesive makes for much easier device access.
- The plastic back cover comes off to reveal the battery, motherboard, and display hiding on the other side.
- We can also see smaller components, including a speaker and a camera.

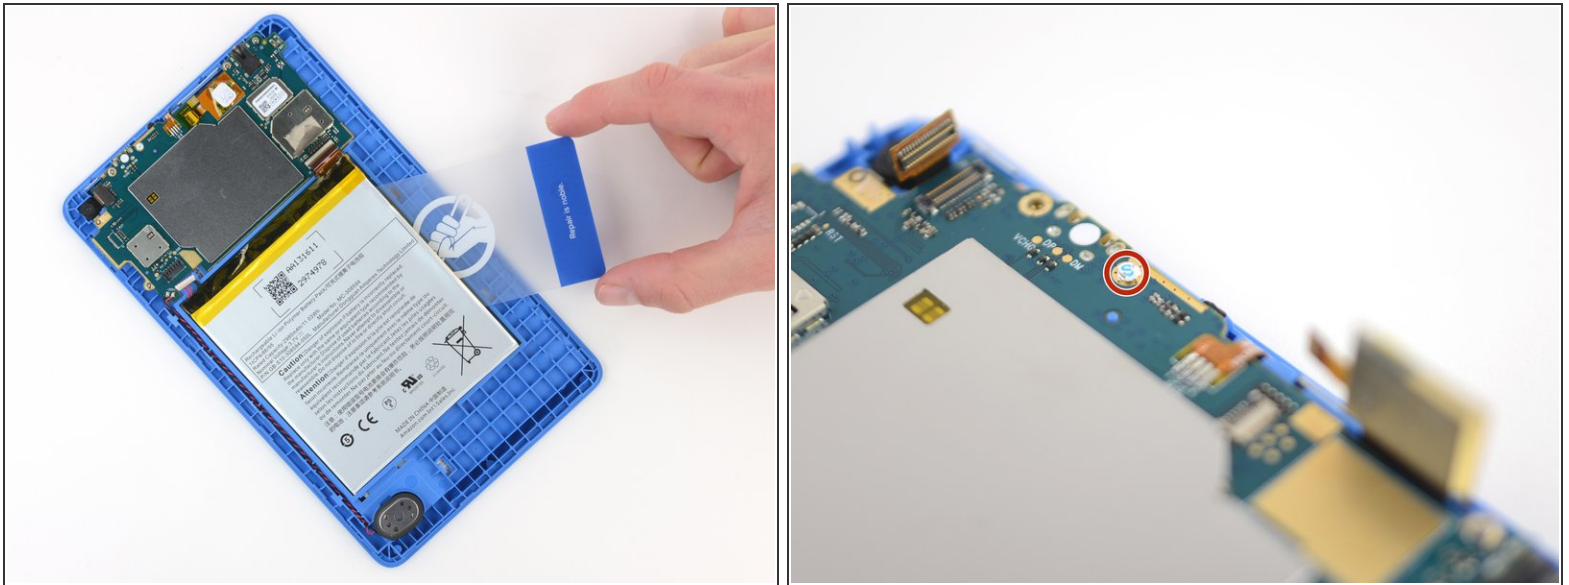
## Step 3

- This battery isn't super easy to remove. It's held in with several adhesive strips that require force to separate.
- We use a card to fight the adhesive and we can pry the battery out with a bit of effort.
- At the top of the motherboard there's a little tamper evident sticker.

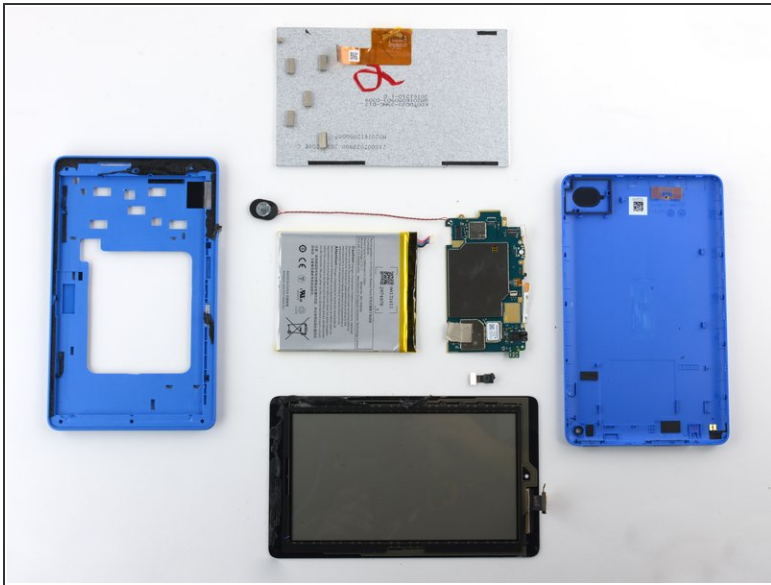
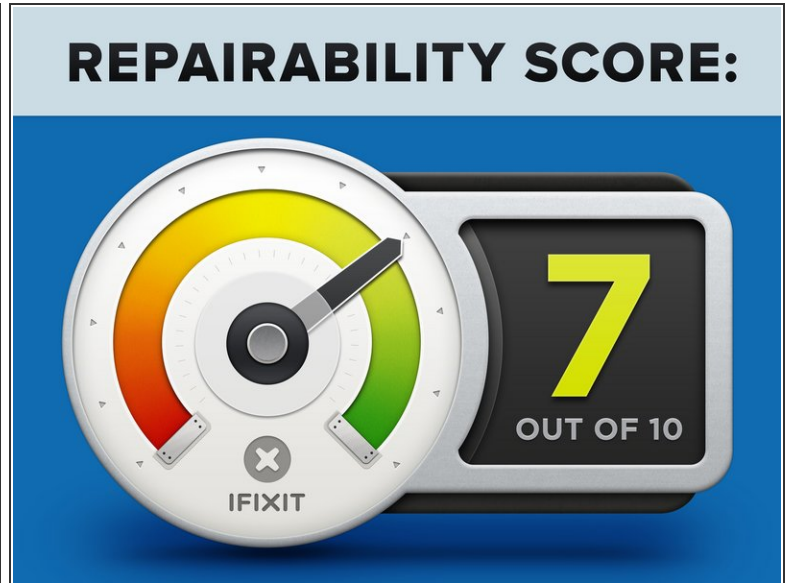
## Step 6

- The Amazon Fire Tablet earns a **7 out of 10** on our repairability scale (10 is the easiest to repair):
  - The plastic case assembly is held together by clips and no adhesive, and opening only requires prying with an iFixit opening tool.
  - The digitizer and LCD panel are not fused together.
  - All of the screws in the device are Phillips screws.
  - The battery is modular, but it is held in place by somewhat stubborn adhesive.
  - Removing the digitizer and LCD panel requires fighting through some very resilient adhesive.
  - Manufacturer does not provide user-accessible repair documentation.
