iRobot Roomba 860 Side Brush Replacement

This guide will provide instructions to replace the side brush that directs debris and contaminants towards the debris extractor to be picked up.

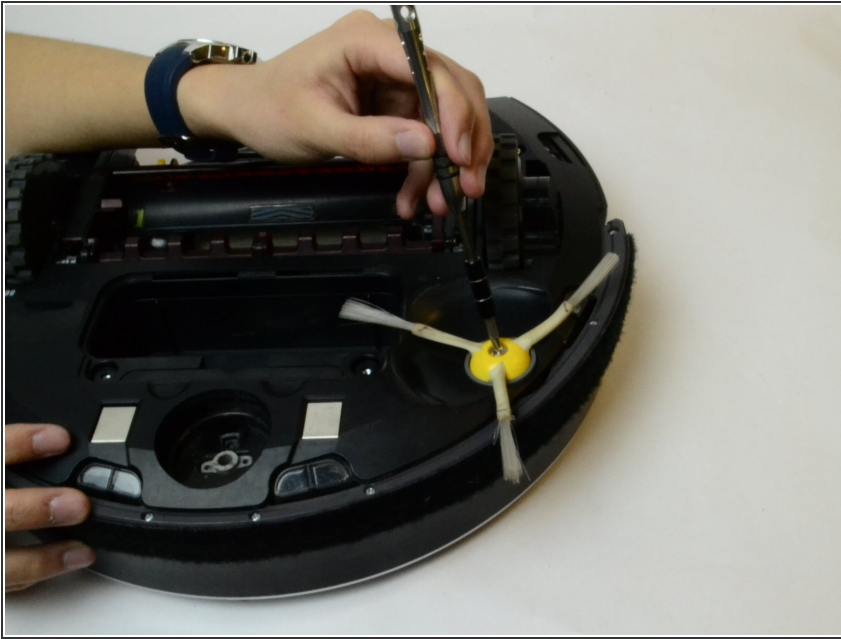
Step 1 — Side Brush

- Start by locating the yellow side brush on the underside of the iRobot Roomba 860 near the front of the device.
