Garmin Edge 520 USB connector repair

Open your Edge 520 so as to get inside to repair a corroded USB connector

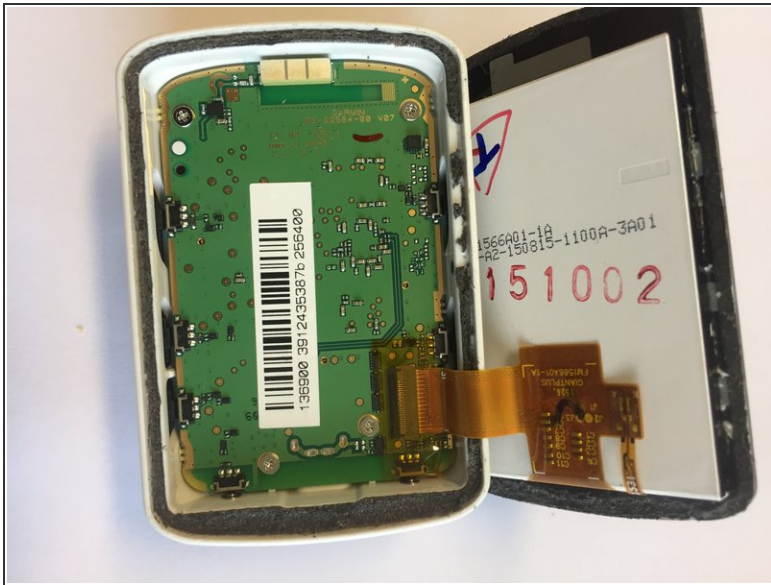
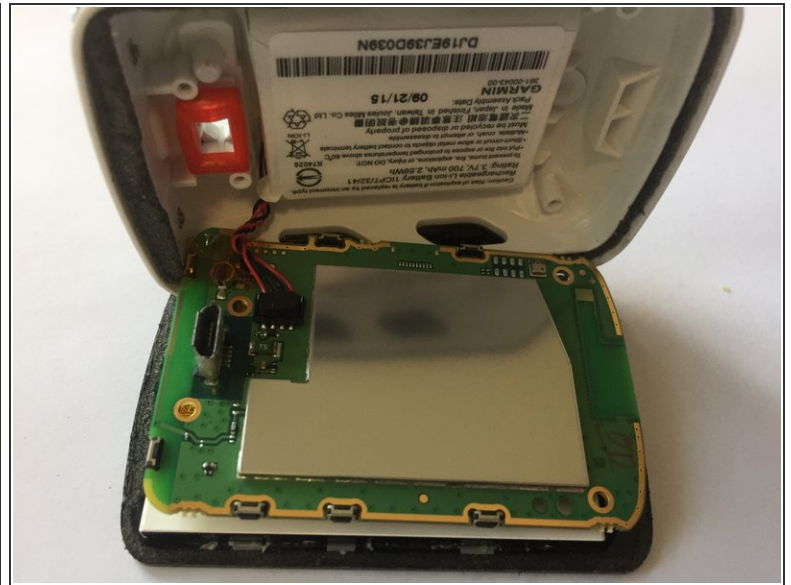
Step 3 — Removing PCB

- Using the Philips head screwdriver, carefully remove the four attachment screws that secure the PCB into the bottom of the case. This will allow you to lift the PCB free of the case and get access to the USB connector
- As you lift the PCB out, you will see where it attaches to the battery. No need to disconnect this (unless you are replacing the battery) as there is enough length in the battery wires to get access to the USB connector
